# Access Compliance Report

## Public Rights-of-Way

### (Curb Ramps)

Intersection ID: 18932	Main Street: GLENHAM_DR	Cross Street: TYVOLA_RD	Location: NE
ADA ID: 81B3CABCB2A5	Ramp Type: PerpDiag	Initial Pass/Fail: Fail	Overall Compliance: No
		Severity Score: 12.5

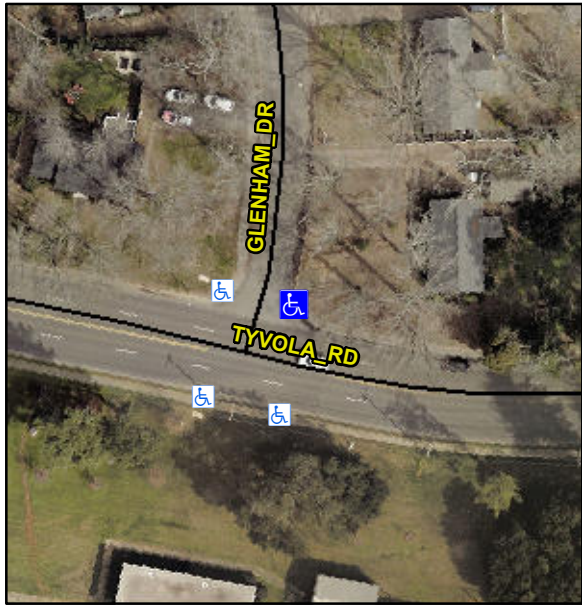
Possible Solutions:			<b>Compliance</b>	<b>Description</b>	<b>Data</b>	<b>Compliance</b>	<b>Description</b>	<b>Data</b>
	<b>Remove &amp; Replace Curb Ramp With Two New Directional Ramps or Equivalent.</b>			N/A	Ramp Length (in)	53.0	No	Ramp Slope (%)	10.0
				Yes	Ramp Width (in)	100.0	Yes	Ramp XSlope (%)	1.8
				N/A	Flare Type LT	N/A	N/A	Flare Type RT	N/A
			N/A	Flare Slope LT (%)	N/A	N/A	Flare Slope RT (%)	N/A	
			N/A	Flare Traversable LT?	N/A	N/A	Flare Traversable RT?	N/A	
			N/A	Landing Length (in)	N/A	N/A	DWS Provided?	N/A	
			N/A	Landing Width (in)	N/A	N/A	DWS Contrast?	N/A	
			N/A	Landing Slope (%)	N/A	N/A	DWS Length (in)	N/A	
			N/A	Landing X Slope (%)	N/A	N/A	DWS Full Width?	N/A	
		N/A	Landing Curb? (Y/N)	N/A	N/A	DWS Offset (in)	N/A		
<p>Surveyor Notes:</p> <p>N/A</p>	PROW/ADA:			N/A	Shared Landing?	N/A

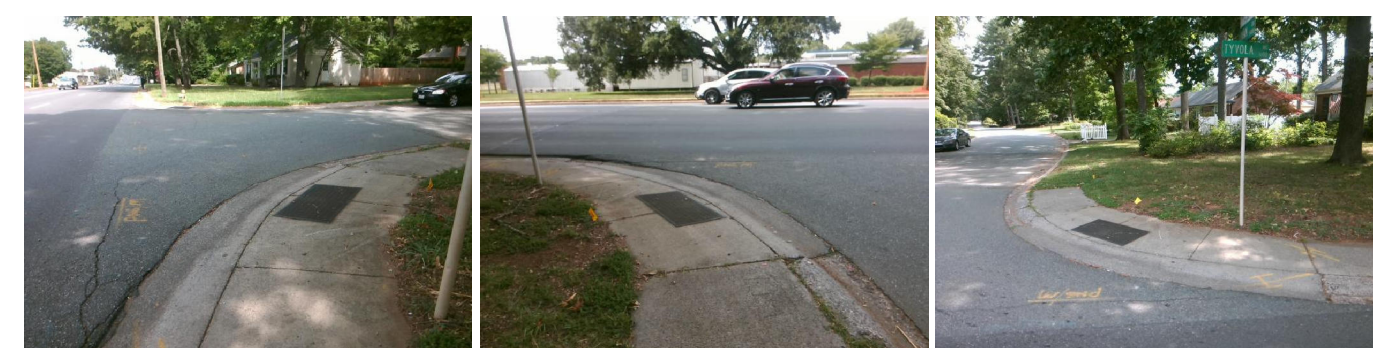
N/A	Gutter Ponding?	N/A	N/A	Gutter Slope (%)	N/A
				N/A	Gutter Lip Ht (in)	N/A	N/A	Gutter X Slope (%)	N/A
				N/A	Painted X Walk1?	No	N/A	Painted X Walk2?	No
					X Walk 1 Direction	To NW		X Walk 2 Direction	To SW
				N/A	X Walk 1 Width (in)	N/A	N/A	X Walk 2 Width (in)	N/A
					X Walk 1 Slope (%)	4.5		X Walk 2 Slope (%)	2.6
					X Walk 1 X Slope (%)	3.4		X Walk 2 X Slope (%)	2.4
				N/A	Ramp inside XWalk1?	N/A	N/A	Ramp inside XWalk2?	N/A
					Road Slope (%)	1.4	N/A	Clear Space?	N/A
<p>Total Cost:</p> <p>\$ 3200.00</p>					Road X Slope (%)	5.7	N/A	Clear Space to XWalk (in)	N/A
				N/A	Any Obstructions?	N/A	N/A	Storm Grate/Utility Hazard?	N/A
					Obstruction Type			Storm Grate/Utility Type	
						N/A			N/A
							Yes	Surface Condition? (G/P)	Good
