## Access Compliance Report Public Rights-of-Way (Curb Ramps)

Intersection ID: 14523 Main Street: LEXINGTON\_AV Cross Street: ROMANY\_RD Location: N

ADA ID: 81C9502DDF32 Ramp Type: Perp Initial Pass/Fail: Fail Overall Compliance: No Severity Score: 26.25

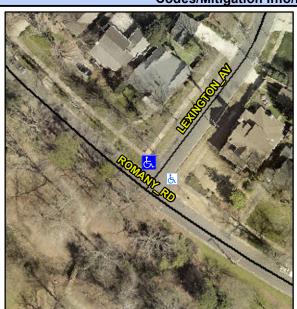
Not Found, R304.2.2, R304.5.3

Compliance Description Data Compliance Description Data No N/A Ramp Length (in) 80.0 Ramp Slope (%) 13.7 No Yes Ramp Width (in) 48.0 Ramp XSlope (%) 4.2 N/A N/A Flare Type LT N/A Flare Type RT N/A N/A N/A N/A Flare Slope RT (%) N/A Flare Slope LT (%) N/A Flare Traversable LT? N/A N/A Flare Traversable RT? N/A N/A N/A N/A **DWS Provided?** N/A Landing Length (in) N/A Landing Width (in) N/A N/A **DWS Contrast?** N/A N/A N/A N/A Landing Slope (%) DWS Length (in) N/A N/A Landing X Slope (%) N/A N/A DWS Full Width? N/A N/A Landing Curb? (Y/N) N/A N/A DWS Offset (in) N/A N/A N/A Shared Landing? N/A **Gutter Ponding?** N/A N/A Gutter Slope (%) N/A N/A Gutter Lip Ht (in) N/A N/A Gutter X Slope (%) N/A N/A Painted X Walk1? No N/A Painted X Walk2? N/A X Walk 1 Direction To SE X Walk 2 Direction N/A N/A N/A X Walk 1 Width (in) X Walk 2 Width (in) N/A X Walk 1 Slope (%) 0.9 X Walk 2 Slope (%) N/A X Walk 1 X Slope (%) 0.1 X Walk 2 X Slope (%) N/A N/A N/A N/A Ramp inside XWalk1? Ramp inside XWalk2? N/A Road Slope (%) N/A N/A Clear Space? N/A Road X Slope (%) N/A N/A Clear Space to XWalk (in) N/A N/A N/A Any Obstructions? N/A Storm Grate/Utility Hazard? N/A **Obstruction Type** Storm Grate/Utility Type N/A N/A

Remove & Replace Entire Ramp.
