Access Compliance Report

Public Rights-of-Way

(Curb Ramps)

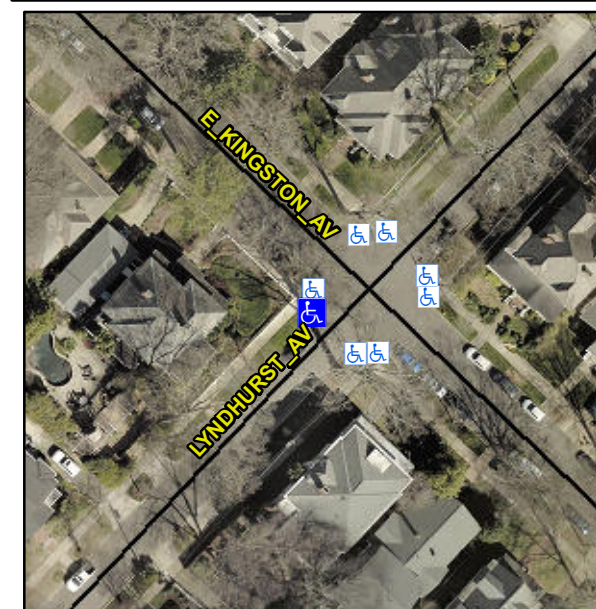
Intersection ID: 14281	Main Street: E_KINGSTON_AV	Cross Street: LYNDHURST_AV	Location: W
ADA ID: 81E16B7492B1	Ramp Type: Directional1	Initial Pass/Fail: Fail	Overall Compliance: No
Severity Score: 1.25			
Codes/Mitigation Info/Possible Solution		Field Measurements/Component Compliance

Compliance	Description	Data	Compliance	Description	Data
N/A	Ramp Length (in)	82.0	N/A	Grade Break?	N/A
Yes	Ramp Width (in)	72.0	N/A	Grade Break Slope (%)	0.0
Yes	Ramp Slope (%)	8.2	N/A	Grade Break XSlope (%)	0.0
No	Ramp XSlope (%)	2.2			
N/A	Flare Type LT	N/A	N/A	Flare Type RT	N/A
N/A	Flare Slope LT (%)	N/A	N/A	Flare Slope RT (%)	0.0
N/A	Flare Traversable LT?	N/A	N/A	Flare Traversable RT?	N/A
N/A	Landing Length (in)	0.0	N/A	DWS Provided?	N/A
N/A	Landing Width (in)	0.0	N/A	DWS Contrast?	N/A
N/A	Landing Slope (%)	0.0	N/A	DWS Length (in)	N/A
N/A	Landing X Slope (%)	0.0	N/A	DWS Full Width?	N/A
N/A	Landing Curb? (Y/N)	N/A	N/A	DWS Offset LT (in)	N/A
N/A	Shared Landing?	N/A	N/A	DWS Offset RT (in)	N/A
N/A	Gutter Ponding?	0.0	N/A	Gutter Slope (%)	N/A
N/A	Gutter Lip Ht (in)	0.0	N/A	Gutter X Slope (%)	N/A
N/A	Painted X Walk1?	No		Road Slope (%)	2.4
	X Walk 1 Direction	To SE		Road X Slope (%)	2.2
	X Walk 1 Width (in)	N/A		Clear Space?	N/A

X Walk 1 Slope (%)	2.4	N/A	Clear Space to XWalk (in)	N/A
	X Walk 1 X Slope (%)	2.2	N/A	Storm Grate/Utility Hazard?	N/A
N/A	Ramp inside XWalk1?	N/A		Storm Grate/Utility Type	
N/A	Any Obstructions?	N/A			N/A
	Obstruction Type		Yes	Surface Condition? (G/P)	Good
			N/A	Curb Slope (%)	0.3

Possible Solutions:

Remove & Replace Entire Ramp.

R304.5.3

\$ 1600.00
