Access Compliance Report

Public Rights-of-Way

(Curb Ramps)

Intersection ID: 7648	Main Street: STARITA_RD	Cross Street: WOODPARK_BV	Location: SW
ADA ID: 81E528A31B0D	Ramp Type: Perp	Initial Pass/Fail: Fail	Overall Compliance: No
			Severity Score: 21.25

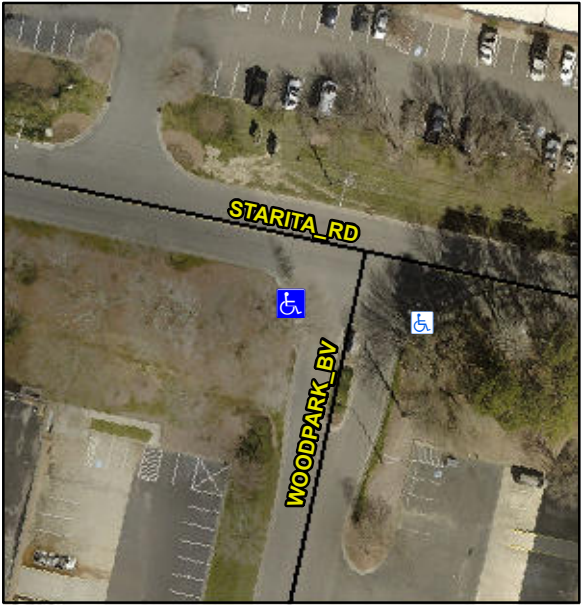
Possible Solutions:		Compliance	Description	Data
	Remove & Replace Entire Ramp.		No	Ramp Length (in)	47.0
			No	Ramp Width (in)	46.0
			N/A	Flare Type LT	N/A
			N/A	Flare Slope LT (%)	N/A
			N/A	Flare Traversable LT?	N/A
			N/A	Landing Length (in)	N/A
			N/A	Landing Width (in)	N/A
			N/A	Landing Slope (%)	N/A
			N/A	Landing X Slope (%)	N/A
<p>Surveyor Notes:</p> <p>N/A</p> <p>PROW/ADA:</p> <p>Not Found, R304.5.1, R304.2.2</p>			N/A	Flare Type RT	N/A
			N/A	Flare Slope RT (%)	N/A
			N/A	Flare Traversable RT?	N/A
			N/A	DWS Provided?	N/A
			N/A	DWS Contrast?	N/A
			N/A	DWS Length (in)	N/A
			N/A	DWS Full Width?	N/A
			N/A	DWS Offset (in)	N/A
			N/A	Gutter Ponding?	N/A
			N/A	Gutter Lip Ht (in)	1.0
			No	Painted X Walk1?	N/A
				X Walk 1 Direction	To SE
			N/A	X Walk 1 Width (in)	N/A
				X Walk 1 Slope (%)	5.3
				X Walk 1 X Slope (%)	3.3

N/A	Ramp inside XWalk1?	N/A
			N/A	Road Slope (%)	N/A
			N/A	Road X Slope (%)	N/A
			N/A	Any Obstructions?	N/A
				Obstruction Type	
Total Cost:					
		\$ 1850.00			
			N/A	Clear Space?	N/A
			N/A	Clear Space to XWalk (in)	N/A
			N/A	Storm Grate/Utility Hazard?	N/A
				Storm Grate/Utility Type	
			N/A		N/A
			Yes	Surface Condition? (G/P)	Good
