# Access Compliance Report

## Public Rights-of-Way

### (Curb Ramps)

Intersection ID: 31467	Main Street: BULLOCK_DR	Cross Street: SENEY_DR	Location: SW
ADA ID: 81F781CBB09B	Ramp Type: PerpDiag	Initial Pass/Fail: Fail	Overall Compliance: No
			Severity Score: 21.25

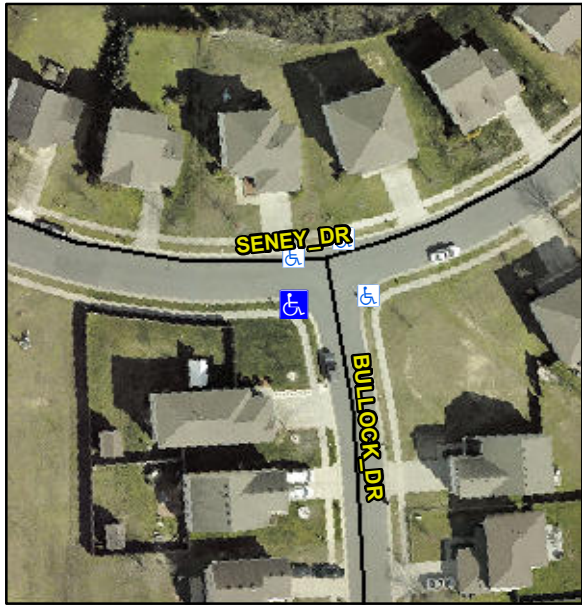
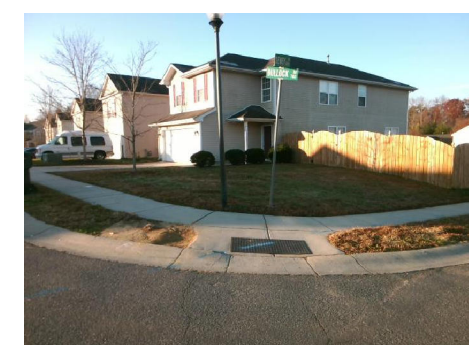
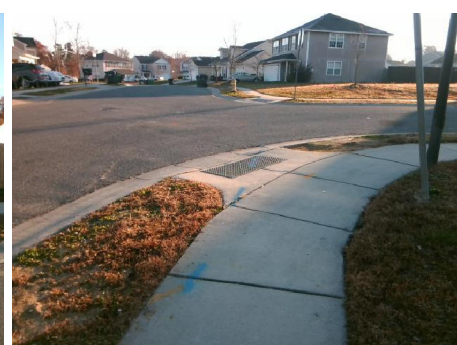
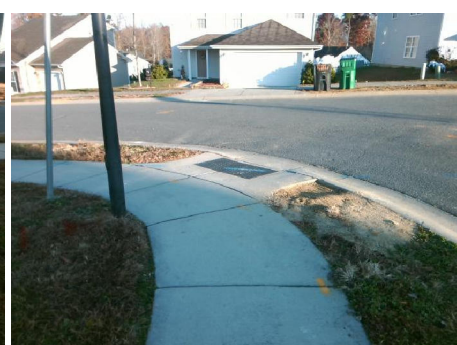
<div>Street 1 Name<div>BULLOCK DR</div></div> <div>Stop Condition-Street 2<div>StopSign</div></div> <div>Street 2 Name<div>SENEY DR</div></div> <div>Stop Condition-Street 1<div>None</div></div>	Possible Solutions:  <b>Remove &amp; Replace Curb Ramp With Two New Directional Ramps or Equivalent.</b>		<b>Compliance</b>	<b>Description</b>	<b>Data</b>	<b>Compliance</b>	<b>Description</b>	<b>Data</b>
			N/A	Ramp Length (in)	47.5	Yes	Ramp Slope (%)	7.0
			No	Ramp Width (in)	42.0	No	Ramp XSlope (%)	6.0
			N/A	Flare Type LT	N/A	N/A	Flare Type RT	N/A
			N/A	Flare Slope LT (%)	N/A	N/A	Flare Slope RT (%)	N/A
			N/A	Flare Traversable LT?	N/A	N/A	Flare Traversable RT?	N/A
			N/A	Landing Length (in)	N/A	N/A	DWS Provided?	N/A
			N/A	Landing Width (in)	N/A	N/A	DWS Contrast?	N/A
			N/A	Landing Slope (%)	N/A	N/A	DWS Length (in)	N/A

N/A	Landing X Slope (%)	N/A	N/A	DWS Full Width?	N/A
		N/A	Landing Curb? (Y/N)	N/A	N/A	DWS Offset (in)	N/A	N/A
		N/A	Shared Landing?	N/A				
		N/A	Gutter Ponding?	N/A	N/A	N/A	Gutter Slope (%)	N/A
		N/A	Gutter Lip Ht (in)	N/A	N/A	N/A	Gutter X Slope (%)	N/A
		N/A	Painted X Walk1?	No	N/A	N/A	Painted X Walk2?	No
			X Walk 1 Direction	To E			X Walk 2 Direction	To N
		N/A	X Walk 1 Width (in)	N/A	N/A	N/A	X Walk 2 Width (in)	N/A
			X Walk 1 Slope (%)	5.5			X Walk 2 Slope (%)	1.3
			X Walk 1 X Slope (%)	2.2			X Walk 2 X Slope (%)	5.5
		N/A	Ramp inside XWalk1?	N/A	N/A	N/A	Ramp inside XWalk2?	N/A
			Road Slope (%)	4.4	N/A	N/A	Clear Space?	N/A
			Road X Slope (%)	3.5	N/A	N/A	Clear Space to XWalk (in)	N/A
		N/A	Any Obstructions?	N/A	N/A	N/A	Storm Grate/Utility Hazard?	N/A
			Obstruction Type				Storm Grate/Utility Type	
					N/A			N/A
						Yes	Surface Condition? (G/P)	Good
Total Cost:		\$ 3200.00
