Access Compliance Report

Public Rights-of-Way

(Curb Ramps)

| Intersection ID: 47269 | Main Street: E_MCCULLOUGH_DR | Cross Street: KEN_HOFFMAN_DR | Location: SW |

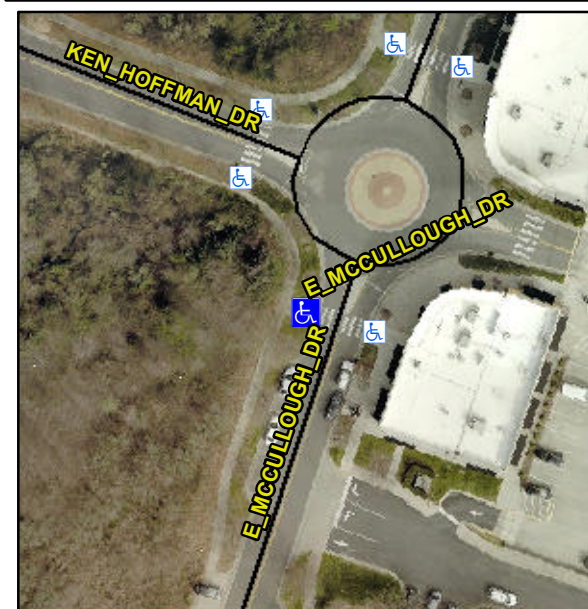
| ADA ID: 82019971EC4D | Ramp Type: Perp | Initial Pass/Fail: Fail | Overall Compliance: No |

| Compliance | Description | Data | Compliance | Description | Data |
|---|---|---|---|---|---|
| N/A | Ramp Length (in) | 178.0 | Yes | Ramp Slope (%) | 5.3 |
| Yes | Ramp Width (in) | 63.0 | Yes | Ramp XSlope (%) | 1.8 |

Possible Solutions:

Remove & Replace Entire Ramp.

Total Cost: \$ **1850.00**

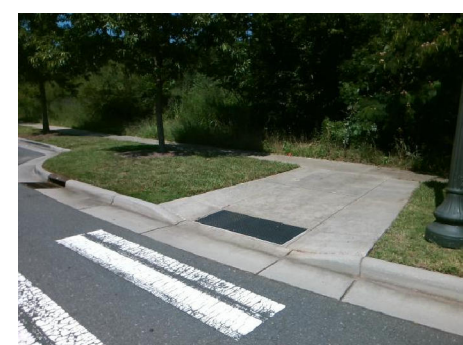
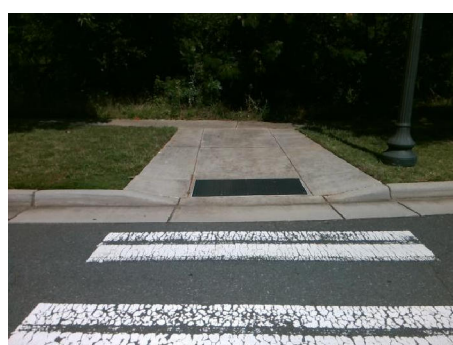
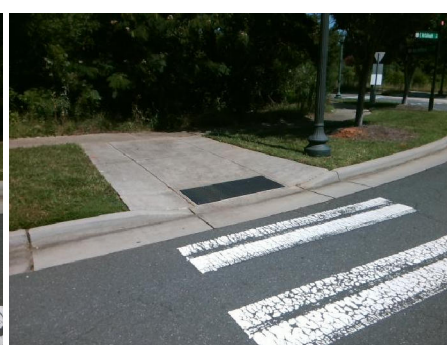
| Compliance | Description | Data | Compliance | Description | Data |
|---|---|---|---|---|---|
| | | | Yes | Surface Condition? (G/P) | Good |
