Access Compliance Report

Public Rights-of-Way

(Curb Ramps)

Intersection ID: 10026712	Main Street: FLENNIKEN_CT	Cross Street: N/A	Location: E
ADA ID: 821E22A20CBC	Ramp Type: Perp	Initial Pass/Fail: Fail	Overall Compliance: No
Severity Score: 22.5			
Codes/Mitigation Info/Possible Solution		Field Measurements/Component Compliance

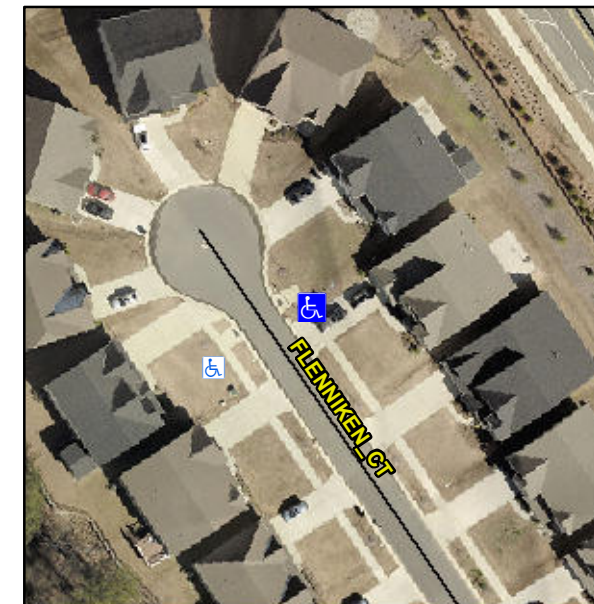
Compliance	Description	Data	Compliance	Description	Data
N/A	Ramp Length (in)	96.0	No	Ramp Slope (%)	9.0
No	Ramp Width (in)	46.5	No	Ramp XSlope (%)	4.6
N/A	Flare Type LT	N/A	N/A	Flare Type RT	N/A
N/A	Flare Slope LT (%)	N/A	N/A	Flare Slope RT (%)	N/A
N/A	Flare Traversable LT?	N/A	N/A	Flare Traversable RT?	N/A
N/A	Landing Length (in)	N/A	N/A	DWS Provided?	N/A
N/A	Landing Width (in)	N/A	N/A	DWS Contrast?	N/A
N/A	Landing Slope (%)	N/A	N/A	DWS Length (in)	N/A
N/A	Landing X Slope (%)	N/A	N/A	DWS Full Width?	N/A
N/A	Landing Curb? (Y/N)	N/A	N/A	DWS Offset (in)	N/A
N/A	Shared Landing?	N/A			
N/A	Gutter Ponding?	N/A	N/A	Gutter Slope (%)	N/A
N/A	Gutter Lip Ht (in)	N/A	N/A	Gutter X Slope (%)	N/A
N/A	Painted X Walk1?	No	N/A	Painted X Walk2?	N/A
	X Walk 1 Direction	To W		X Walk 2 Direction	N/A
N/A	X Walk 1 Width (in)	N/A	N/A	X Walk 2 Width (in)	N/A
	X Walk 1 Slope (%)	4.4		X Walk 2 Slope (%)	N/A
	X Walk 1 X Slope (%)	3.4		X Walk 2 X Slope (%)	N/A

N/A	Ramp inside XWalk1?	N/A	N/A	Ramp inside XWalk2?	N/A
	Road Slope (%)	N/A	N/A	Clear Space?	N/A
	Road X Slope (%)	N/A	N/A	Clear Space to XWalk (in)	N/A
N/A	Any Obstructions?	N/A	N/A	Storm Grate/Utility Hazard?	N/A
	Obstruction Type			Storm Grate/Utility Type	
		N/A			N/A
			Yes	Surface Condition? (G/P)	Good

Remove & Replace Entire Ramp.

R304.5.1, R304.2.2, R304.5.3
