Access Compliance Report

Public Rights-of-Way

(Curb Ramps)

Intersection ID: 11882	Main Street: N_PINE_ST	Cross Street: W_5TH_ST	Location:	E
ADA ID: 823C27472A7C	Ramp Type: Perp	Initial Pass/Fail: Fail	Overall Compliance: No	Severity Score: 25
Codes/Mitigation Info/Possible Solution		Field Measurements/Component Compliance

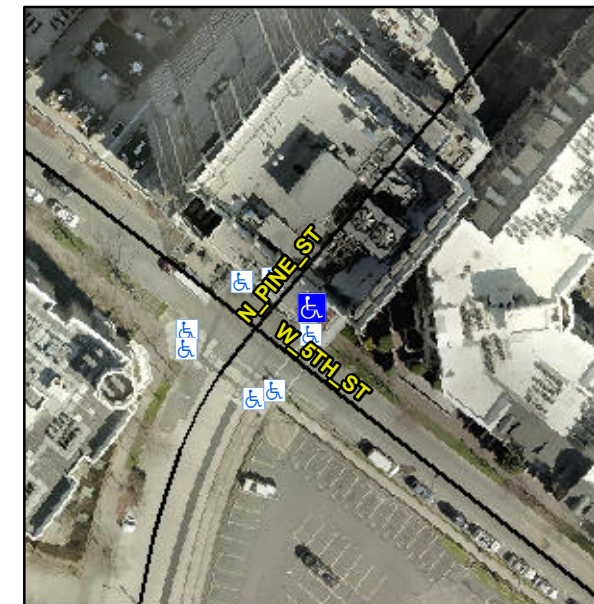
R304.2.2, R304.5.3

Compliance	Description	Data	Compliance	Description	Data
N/A	Ramp Length (in)	74.0	No	Ramp Slope (%)	11.2
Yes	Ramp Width (in)	60.0	No	Ramp XSlope (%)	6.3
N/A	Flare Type LT	N/A	N/A	Flare Type RT	N/A
N/A	Flare Slope LT (%)	N/A	N/A	Flare Slope RT (%)	N/A
N/A	Flare Traversable LT?	N/A	N/A	Flare Traversable RT?	N/A
N/A	Landing Length (in)	N/A	N/A	DWS Provided?	N/A
N/A	Landing Width (in)	N/A	N/A	DWS Contrast?	N/A
N/A	Landing Slope (%)	N/A	N/A	DWS Length (in)	N/A
N/A	Landing X Slope (%)	N/A	N/A	DWS Full Width?	N/A
N/A	Landing Curb? (Y/N)	N/A	N/A	DWS Offset (in)	N/A
N/A	Shared Landing?	N/A			
N/A	Gutter Ponding?	N/A	N/A	Gutter Slope (%)	N/A
N/A	Gutter Lip Ht (in)	N/A	N/A	Gutter X Slope (%)	N/A
N/A	Painted X Walk1?	Yes	N/A	Painted X Walk2?	N/A
	X Walk 1 Direction	To NW		X Walk 2 Direction	N/A
N/A	X Walk 1 Width (in)	100.0	N/A	X Walk 2 Width (in)	N/A
	X Walk 1 Slope (%)	2.6		X Walk 2 Slope (%)	N/A
	X Walk 1 X Slope (%)	6.9		X Walk 2 X Slope (%)	N/A

N/A	Ramp inside XWalk1?	Yes	N/A	Ramp inside XWalk2?	N/A
	Road Slope (%)	N/A	N/A	Clear Space?	N/A
	Road X Slope (%)	N/A	N/A	Clear Space to XWalk (in)	N/A
N/A	Any Obstructions?	N/A	N/A	Storm Grate/Utility Hazard?	N/A
	Obstruction Type			Storm Grate/Utility Type	
		N/A			N/A
			Yes	Surface Condition? (G/P)	Good

Possible Solutions:

Remove & Replace Entire Ramp.
