Access Compliance Report Public Rights-of-Way (Curb Ramps)

•	•	,			_		
Intersection ID: 50612	Main Street: YELLOW_OAK_RD				Cross Street: DOWNY_BIRCH_RD				Location:	w
ADA ID: 82437D22BBCE	CE Ramp Type: Perp			Initial	Initial Pass/Fail: Pass Overall Compliance: No				o Severity Score:	5.25
Codes/Mitigation Info/Possible Solution					Field Measurements/Component Compliance					
	the second	Possible Solutions:			Compliance Description			Data Compliance Description		
		Remove & Replace Ent	tire Ram	D.	N/A	Ramp Length (in)	48.5	Yes	Ramp Slope (%)	5.5
	6 A	Remove & Replace Gu		P -	Yes	Ramp Width (in)	48.0	No	Ramp XSlope (%)	4.9
NEW	b. d.	-			N/A	Flare Type LT	Sloped	N/A	Flare Type RT	N/A
NON ON	11 Mar 11/2				N/A	Flare Slope LT (%)	9.0	N/A	Flare Slope RT (%)	0.9
CO.S.	and the second				N/A	Flare Traversable LT?	No	N/A	Flare Traversable RT?	No
ASA & N					No	Landing Length (in)	47.0	Yes	DWS Provided?	Yes
	St A	Surveyor Notes:			Yes	Landing Width (in)	84.0	Yes	DWS Contrast?	Yes

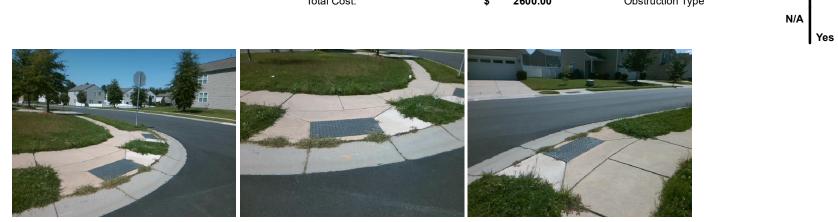
N/A			No	Landing Slope (%)	4.7	Yes	DWS Length (in)	24.0
538V	AN VI				No	Landing X Slope (%)	6.6	Yes	DWS Full Width?	Yes
				N/A	Landing Curb? (Y/N)	No	No	DWS Offset (in)	5.5	
				N/A	Shared Landing?	Yes				
	PROW/ADA:			Yes	Gutter Ponding?	No	No	Gutter Slope (%)	7.9	
		Not Found, R304.5.3, R	5.3. R304.2.1.		Yes	Gutter Lip Ht (in)	0.0	No	Gutter X Slope (%)	3.9
	R304.2.2-Perp, R304.3.			N/A	Painted X Walk1?	No	N/A	Painted X Walk2?	N/A	
. //	R305.2, R304.5.4				X Walk 1 Direction	To S		X Walk 2 Direction	N/A	
				N/A	X Walk 1 Width (in)	N/A	N/A	X Walk 2 Width (in)	N/A	
Street 1 Name	DOWNY BIRCH RD	-				X Walk 1 Slope (%)	4.4		X Walk 2 Slope (%)	N/A
Stop Condition-Street 2	None					X Walk 1 X Slope (%)	0.9		X Walk 2 X Slope (%)	N/A
Street 2 Name	N/A				N/A	Ramp inside XWalk1?	N/A	N/A	Ramp inside XWalk2?	N/A
Stop Condition-Street 1	N/A					Road Slope (%)	N/A	N/A	Clear Space?	Yes
						Road X Slope (%)	N/A	N/A	Clear Space to XWalk (in)	N/A

Yes	Any Obstructions?	No	Yes	Storm Grate/Utility Hazard?	No
		Total Cost:	\$	2600.00		Obstruction Type			Storm Grate/Utility Type	
			-				N/A			N/A
