# Access Compliance Report

## Public Rights-of-Way

### (Curb Ramps)

Intersection ID: 44317	Main Street: E_9TH_ST	Cross Street: N_CALDWELL_ST	Location: N
ADA ID: 8244B3A67C7F	Ramp Type: PerpDiag	Initial Pass/Fail: Fail	Overall Compliance: No
		Severity Score: 47.5	
Codes/Mitigation Info/Possible Solution		Field Measurements/Component Compliance

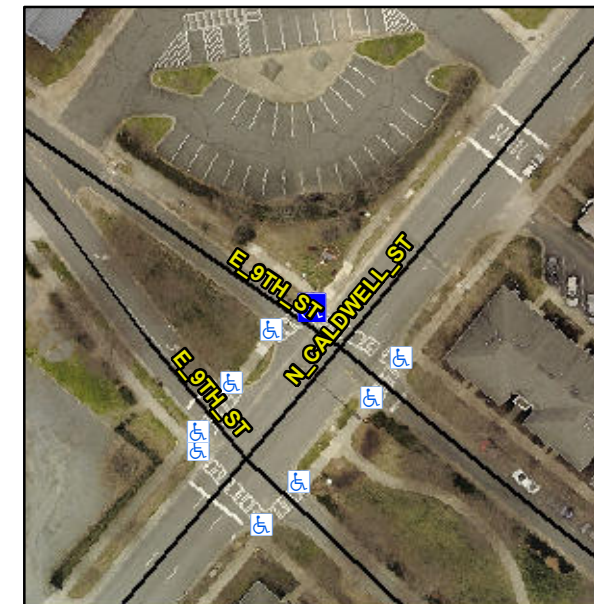
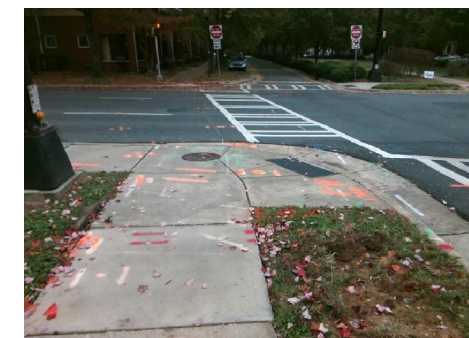
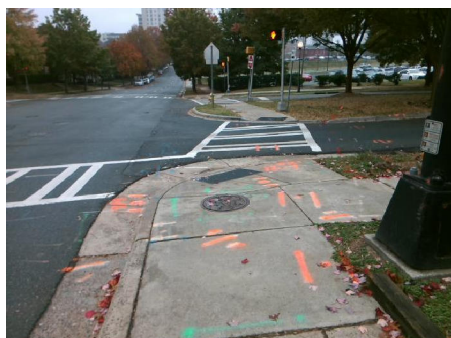
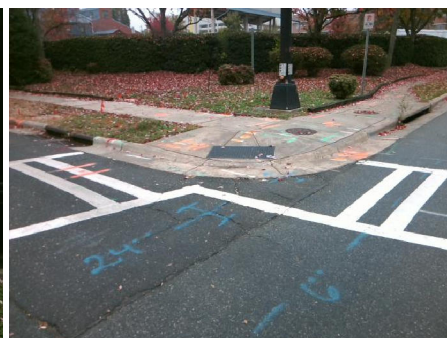
**Not Found, R304.5.1, R304.2.2**

Compliance	Description	Data	Compliance	Description	Data
N/A	Ramp Length (in)	90.0	No	Ramp Slope (%)	11.6
No	Ramp Width (in)	24.0	Yes	Ramp XSlope (%)	1.2
N/A	Flare Type LT	N/A	N/A	Flare Type RT	N/A
N/A	Flare Slope LT (%)	N/A	N/A	Flare Slope RT (%)	N/A
N/A	Flare Traversable LT?	N/A	N/A	Flare Traversable RT?	N/A
N/A	Landing Length (in)	N/A	N/A	DWS Provided?	N/A
N/A	Landing Width (in)	N/A	N/A	DWS Contrast?	N/A
N/A	Landing Slope (%)	N/A	N/A	DWS Length (in)	N/A
N/A	Landing X Slope (%)	N/A	N/A	DWS Full Width?	N/A
N/A	Landing Curb? (Y/N)	N/A	N/A	DWS Offset (in)	N/A
N/A	Shared Landing?	N/A			
N/A	Gutter Ponding?	N/A	N/A	Gutter Slope (%)	N/A
N/A	Gutter Lip Ht (in)	0.5	N/A	Gutter X Slope (%)	N/A
N/A	Painted X Walk1?	Yes	N/A	Painted X Walk2?	Yes
	X Walk 1 Direction	To SW		X Walk 2 Direction	To SE
N/A	X Walk 1 Width (in)	105.5	N/A	X Walk 2 Width (in)	100.0
	X Walk 1 Slope (%)	0.2		X Walk 2 Slope (%)	0.9
	X Walk 1 X Slope (%)	1.1		X Walk 2 X Slope (%)	2.0

N/A	Ramp inside XWalk1?	Yes	N/A	Ramp inside XWalk2?	Yes
	Road Slope (%)	0.2	N/A	Clear Space?	N/A
	Road X Slope (%)	0.2	N/A	Clear Space to XWalk (in)	N/A
N/A	Any Obstructions?	N/A	N/A	Storm Grate/Utility Hazard?	N/A
	Obstruction Type			Storm Grate/Utility Type	
		N/A			N/A
		Yes		Surface Condition? (G/P)	Good

**Remove & Replace Curb Ramp With Two New Directional Ramps or Equivalent.**
