# Access Compliance Report

## Public Rights-of-Way

### (Curb Ramps)

Intersection ID: 2847	Main Street: BITTERBUSH_CT	Cross Street: WATERELM_LN	Location:	W
ADA ID: 824C00EA71E9	Ramp Type: Perp	Initial Pass/Fail: Fail	Overall Compliance: No	Severity Score: 47.5
Codes/Mitigation Info/Possible Solution		Field Measurements/Component Compliance

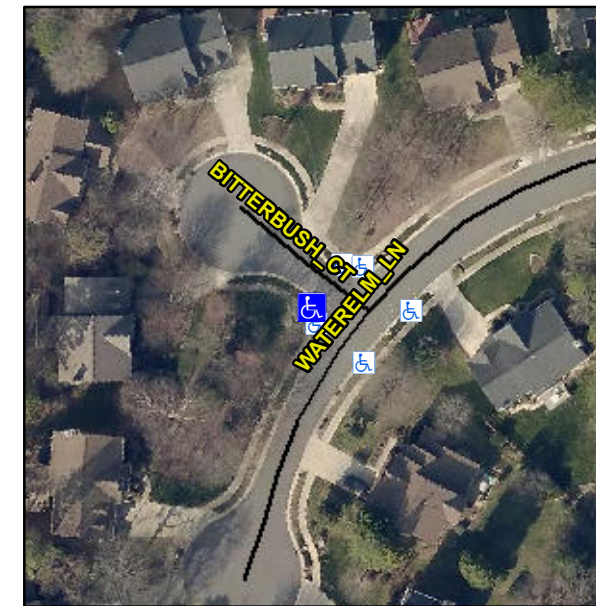
**Not Found, R304.5.1, R304.5.3**

Compliance	Description	Data	Compliance	Description	Data
N/A	Ramp Length (in)	48.0	Yes	Ramp Slope (%)	6.5
No	Ramp Width (in)	24.0	No	Ramp XSlope (%)	6.5
N/A	Flare Type LT	N/A	N/A	Flare Type RT	N/A
N/A	Flare Slope LT (%)	N/A	N/A	Flare Slope RT (%)	N/A
N/A	Flare Traversable LT?	N/A	N/A	Flare Traversable RT?	N/A
N/A	Landing Length (in)	N/A	N/A	DWS Provided?	N/A
N/A	Landing Width (in)	N/A	N/A	DWS Contrast?	N/A
N/A	Landing Slope (%)	N/A	N/A	DWS Length (in)	N/A
N/A	Landing X Slope (%)	N/A	N/A	DWS Full Width?	N/A
N/A	Landing Curb? (Y/N)	N/A	N/A	DWS Offset (in)	N/A
N/A	Shared Landing?	N/A			
N/A	Gutter Ponding?	N/A	N/A	Gutter Slope (%)	N/A
N/A	Gutter Lip Ht (in)	N/A	N/A	Gutter X Slope (%)	N/A
N/A	Painted X Walk1?	No	N/A	Painted X Walk2?	N/A
	X Walk 1 Direction	To NE		X Walk 2 Direction	N/A
N/A	X Walk 1 Width (in)	N/A	N/A	X Walk 2 Width (in)	N/A
	X Walk 1 Slope (%)	1.3		X Walk 2 Slope (%)	N/A
	X Walk 1 X Slope (%)	6.0		X Walk 2 X Slope (%)	N/A

N/A	Ramp inside XWalk1?	N/A	N/A	Ramp inside XWalk2?	N/A
	Road Slope (%)	N/A	N/A	Clear Space?	N/A
	Road X Slope (%)	N/A	N/A	Clear Space to XWalk (in)	N/A
N/A	Any Obstructions?	N/A	N/A	Storm Grate/Utility Hazard?	N/A
	Obstruction Type			Storm Grate/Utility Type	
		N/A			N/A
			Yes	Surface Condition? (G/P)	Good

**Remove & Replace Entire Ramp.**

Total Cost: \$ 1850.00
