# Access Compliance Report

## Public Rights-of-Way

### (Curb Ramps)

Intersection ID: 12219	Main Street: S_CEDAR_ST	Cross Street: W_HILL_ST	Location: NE
ADA ID: 8258111120B2	Ramp Type: BlendTrans1	Initial Pass/Fail: Fail	Overall Compliance: No
		Severity Score: 8.75	
Codes/Mitigation Info/Possible Solution		Field Measurements/Component Compliance

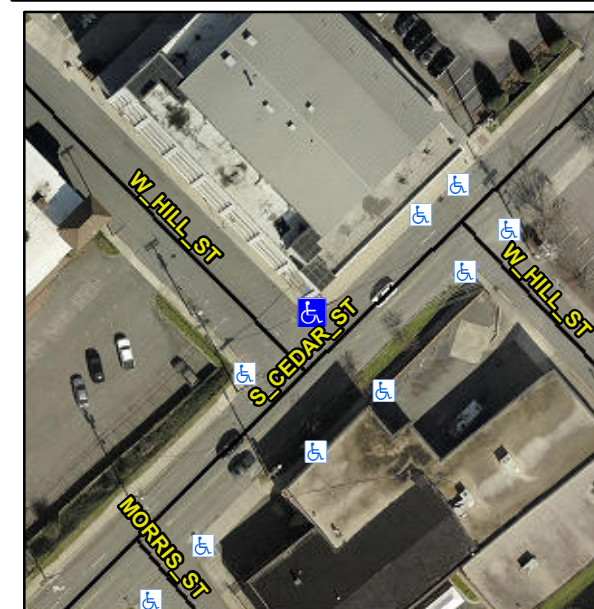
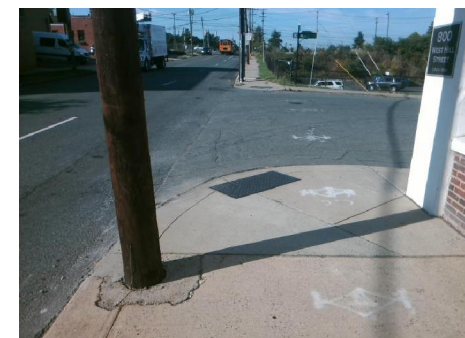
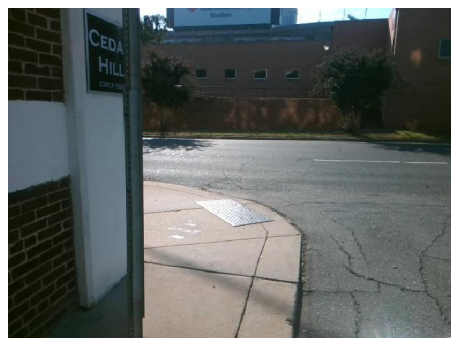
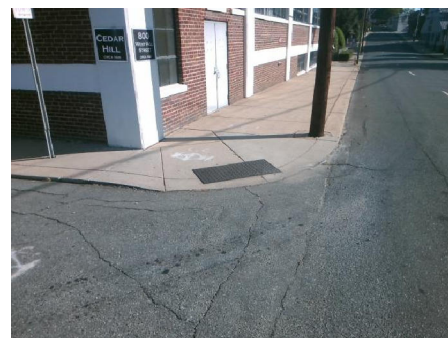
Compliance	Description	Data	Compliance	Description	Data
N/A	Ramp Length (in)	58.0	Yes	BlendTrans Slope (%)	1.6
No	Ramp Width (in)	45.0	Yes	BlendTrans XSlope (%)	0.3
N/A	Flare Type LT	N/A	N/A	Flare Type RT	N/A
N/A	Flare Slope LT (%)	N/A	N/A	Flare Slope RT (%)	N/A
N/A	Flare Traversable LT?	N/A	N/A	Flare Traversable RT?	N/A
N/A	Landing Length (in)	N/A	N/A	DWS Provided?	N/A
N/A	Landing Width (in)	N/A	N/A	DWS Contrast?	N/A
N/A	Landing Slope (%)	N/A	N/A	DWS Length (in)	N/A
N/A	Landing X Slope (%)	N/A	N/A	DWS Full Width?	N/A
N/A	Landing Curb? (Y/N)	N/A	N/A	DWS Offset (in)	N/A
N/A	Shared Landing?	N/A			
N/A	Gutter Ponding?	N/A	N/A	Gutter Slope (%)	N/A
N/A	Gutter Lip Ht (in)	N/A	N/A	Gutter X Slope (%)	N/A
N/A	Painted X Walk1?	No	N/A	Painted X Walk2?	No
	X Walk 1 Direction	To W		X Walk 2 Direction	To S
	X Walk 1 Width (in)	N/A		X Walk 2 Width (in)	N/A
	X Walk 1 Slope (%)	3.4		X Walk 2 Slope (%)	3.2
	X Walk 1 X Slope (%)	1.9		X Walk 2 X Slope (%)	3.0

N/A	Ramp inside XWalk1?	N/A	N/A	Ramp inside XWalk2?	N/A
	Road Slope (%)	0.8		Clear Space?	N/A
	Road X Slope (%)	4.9	N/A	Clear Space to XWalk (in)	N/A
N/A	Any Obstructions?	N/A	N/A	Storm Grate/Utility Hazard?	N/A
	Obstruction Type			Storm Grate/Utility Type	
		N/A			N/A
			Yes	Surface Condition? (G/P)	Good
			N/A	Curb Slope (%)	1.9

Possible Solutions:

**Remove & Replace Curb Ramp With Two New Directional Ramps or Equivalent.**

**R304.5.1**
