Access Compliance Report

Public Rights-of-Way

(Curb Ramps)

Intersection ID: 24485	Main Street: CAMAROSS_DR	Cross Street: SAINTFIELD_PL	Location: NW
ADA ID: 825859DD73F9	Ramp Type: Perp	Initial Pass/Fail: Fail	Overall Compliance: No
Severity Score: 8.75			
Codes/Mitigation Info/Possible Solution		Field Measurements/Component Compliance

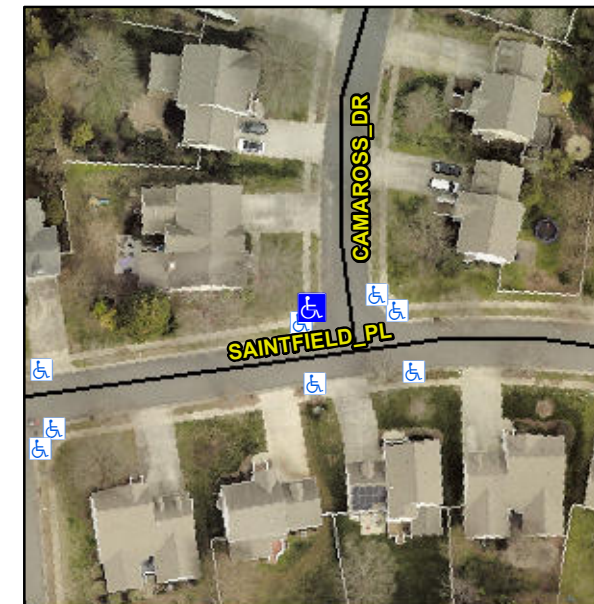
Not Found, R304.5.1

Compliance	Description	Data	Compliance	Description	Data
N/A	Ramp Length (in)	48.0	Yes	Ramp Slope (%)	5.6
No	Ramp Width (in)	37.0	Yes	Ramp XSlope (%)	0.6
N/A	Flare Type LT	N/A	N/A	Flare Type RT	N/A
N/A	Flare Slope LT (%)	N/A	N/A	Flare Slope RT (%)	N/A
N/A	Flare Traversable LT?	N/A	N/A	Flare Traversable RT?	N/A
N/A	Landing Length (in)	N/A	N/A	DWS Provided?	N/A
N/A	Landing Width (in)	N/A	N/A	DWS Contrast?	N/A
N/A	Landing Slope (%)	N/A	N/A	DWS Length (in)	N/A
N/A	Landing X Slope (%)	N/A	N/A	DWS Full Width?	N/A
N/A	Landing Curb? (Y/N)	N/A	N/A	DWS Offset (in)	N/A
N/A	Shared Landing?	N/A			
N/A	Gutter Ponding?	N/A	N/A	Gutter Slope (%)	N/A
N/A	Gutter Lip Ht (in)	N/A	N/A	Gutter X Slope (%)	N/A
N/A	Painted X Walk1?	No	N/A	Painted X Walk2?	N/A
	X Walk 1 Direction	To E		X Walk 2 Direction	N/A
N/A	X Walk 1 Width (in)	N/A	N/A	X Walk 2 Width (in)	N/A
	X Walk 1 Slope (%)	2.7		X Walk 2 Slope (%)	N/A
	X Walk 1 X Slope (%)	2.0		X Walk 2 X Slope (%)	N/A

N/A	Ramp inside XWalk1?	N/A	N/A	Ramp inside XWalk2?	N/A
	Road Slope (%)	N/A	N/A	Clear Space?	N/A
	Road X Slope (%)	N/A	N/A	Clear Space to XWalk (in)	N/A
N/A	Any Obstructions?	N/A	N/A	Storm Grate/Utility Hazard?	N/A
	Obstruction Type			Storm Grate/Utility Type	
		N/A			N/A
			Yes	Surface Condition? (G/P)	Good

Remove & Replace Entire Ramp.
