# Access Compliance Report

## Public Rights-of-Way

### (Curb Ramps)

Intersection ID: 28622	Main Street: PEDLAR_MILLS_RD	Cross Street: STRINGFELLOW_LN	Location: SW
ADA ID: 82616E1FBEF1	Ramp Type: PerpDiag	Initial Pass/Fail: Fail	Overall Compliance: No
Codes/Mitigation Info/Possible Solution		Field Measurements/Component Compliance	
Severity Score: 21.25

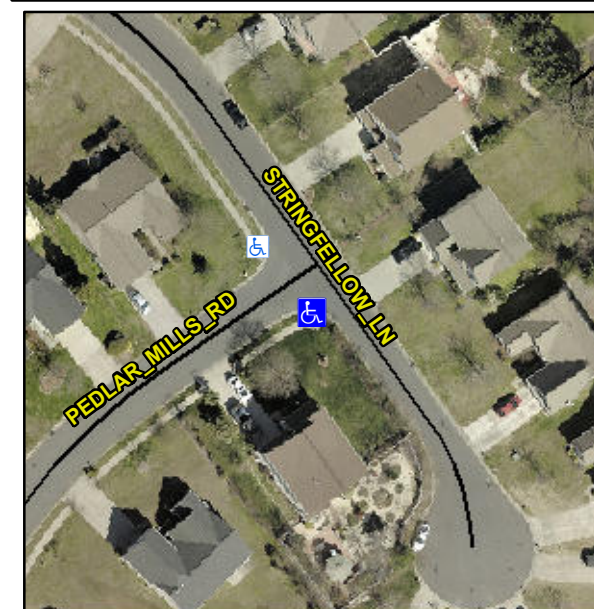
**Not Found, R304.5.1, R304.2.2**

Compliance	Description	Data	Compliance	Description	Data
N/A	Ramp Length (in)	50.0	No	Ramp Slope (%)	9.1
No	Ramp Width (in)	44.5	Yes	Ramp XSlope (%)	0.7
N/A	Flare Type LT	N/A	N/A	Flare Type RT	N/A
N/A	Flare Slope LT (%)	N/A	N/A	Flare Slope RT (%)	N/A
N/A	Flare Traversable LT?	N/A	N/A	Flare Traversable RT?	N/A
N/A	Landing Length (in)	N/A	N/A	DWS Provided?	N/A
N/A	Landing Width (in)	N/A	N/A	DWS Contrast?	N/A
N/A	Landing Slope (%)	N/A	N/A	DWS Length (in)	N/A
N/A	Landing X Slope (%)	N/A	N/A	DWS Full Width?	N/A
N/A	Landing Curb? (Y/N)	N/A	N/A	DWS Offset (in)	N/A
N/A	Shared Landing?	N/A			
N/A	Gutter Ponding?	N/A	N/A	Gutter Slope (%)	N/A
N/A	Gutter Lip Ht (in)	N/A	N/A	Gutter X Slope (%)	N/A
N/A	Painted X Walk1?	No	N/A	Painted X Walk2?	No
	X Walk 1 Direction	To NE		X Walk 2 Direction	To NW
N/A	X Walk 1 Width (in)	N/A	N/A	X Walk 2 Width (in)	N/A
	X Walk 1 Slope (%)	4.2		X Walk 2 Slope (%)	3.0
	X Walk 1 X Slope (%)	2.3		X Walk 2 X Slope (%)	1.0

N/A	Ramp inside XWalk1?	N/A	N/A	Ramp inside XWalk2?	N/A
	Road Slope (%)	2.0	N/A	Clear Space?	N/A
	Road X Slope (%)	3.7	N/A	Clear Space to XWalk (in)	N/A
N/A	Any Obstructions?	N/A	N/A	Storm Grate/Utility Hazard?	N/A
	Obstruction Type			Storm Grate/Utility Type	
		N/A			N/A
			Yes	Surface Condition? (G/P)	Good

**Remove & Replace Curb Ramp With Two New Directional Ramps or Equivalent.**

Total Cost: \$ 3200.00
