Access Compliance Report

Public Rights-of-Way

(Curb Ramps)

Intersection ID: 22096	Main Street: COLONY_RD	Cross Street: CARMEL_CRESCENT_DR	Location: SW
ADA ID: 8262A1187A34	Ramp Type: PerpDiag	Initial Pass/Fail: Fail	Overall Compliance: No
		Severity Score: 8.75

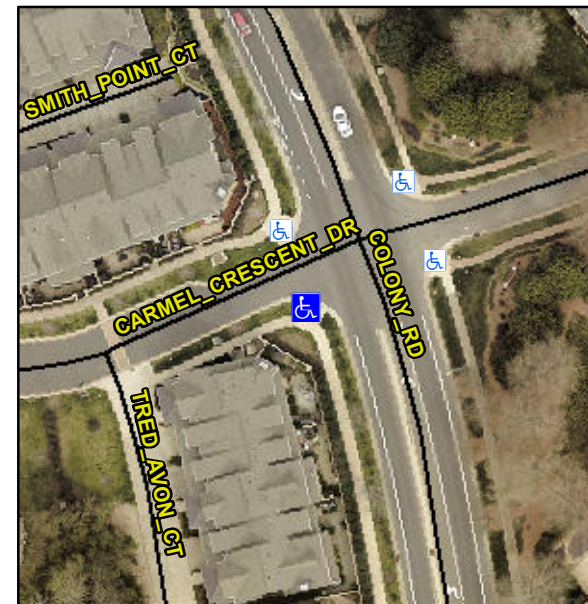
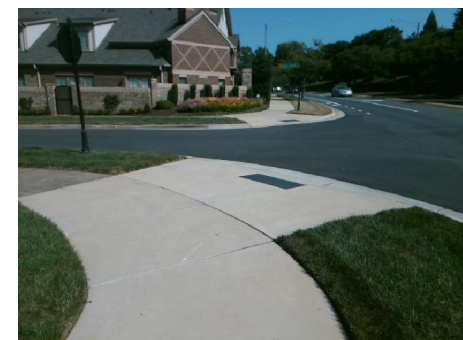
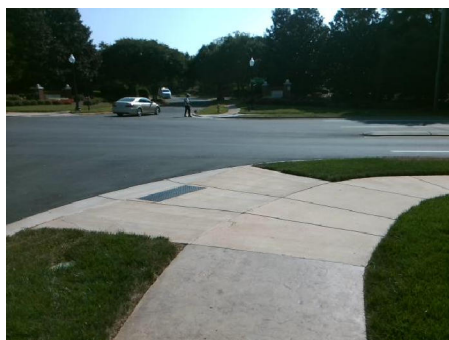
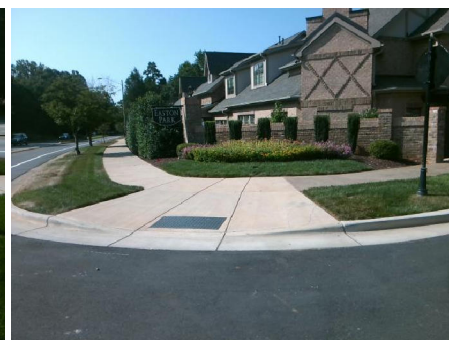
Not Found, R304.5.1

Compliance	Description	Data	Compliance	Description	Data
N/A	Ramp Length (in)	97.0	Yes	Ramp Slope (%)	6.4
No	Ramp Width (in)	41.0	Yes	Ramp XSlope (%)	2.0
N/A	Flare Type LT	N/A	N/A	Flare Type RT	N/A
N/A	Flare Slope LT (%)	N/A	N/A	Flare Slope RT (%)	N/A
N/A	Flare Traversable LT?	N/A	N/A	Flare Traversable RT?	N/A
N/A	Landing Length (in)	N/A	N/A	DWS Provided?	N/A
N/A	Landing Width (in)	N/A	N/A	DWS Contrast?	N/A
N/A	Landing Slope (%)	N/A	N/A	DWS Length (in)	N/A
N/A	Landing X Slope (%)	N/A	N/A	DWS Full Width?	N/A
N/A	Landing Curb? (Y/N)	N/A	N/A	DWS Offset (in)	N/A
N/A	Shared Landing?	N/A			
N/A	Gutter Ponding?	N/A	N/A	Gutter Slope (%)	N/A
N/A	Gutter Lip Ht (in)	N/A	N/A	Gutter X Slope (%)	N/A
N/A	Painted X Walk1?	No	N/A	Painted X Walk2?	No
	X Walk 1 Direction	To E		X Walk 2 Direction	To N
N/A	X Walk 1 Width (in)	N/A	N/A	X Walk 2 Width (in)	N/A
	X Walk 1 Slope (%)	2.8		X Walk 2 Slope (%)	3.7
	X Walk 1 X Slope (%)	4.2		X Walk 2 X Slope (%)	3.7

N/A	Ramp inside XWalk1?	N/A	N/A	Ramp inside XWalk2?	N/A
	Road Slope (%)	0.8	N/A	Clear Space?	N/A
	Road X Slope (%)	4.4	N/A	Clear Space to XWalk (in)	N/A
N/A	Any Obstructions?	N/A	N/A	Storm Grate/Utility Hazard?	N/A
	Obstruction Type			Storm Grate/Utility Type	
		N/A			N/A
			Yes	Surface Condition? (G/P)	Good

Remove & Replace Curb Ramp With Two New Directional Ramps or Equivalent.
