Access Compliance Report

Public Rights-of-Way

(Curb Ramps)

Intersection ID: 43118	Main Street: GRACE_ST	Cross Street: THE_PLAZA	Location: E
ADA ID: 8277859B09B8	Ramp Type: Perp	Initial Pass/Fail: Fail	Overall Compliance: No
Severity Score: 21.25			
Codes/Mitigation Info/Possible Solution		Field Measurements/Component Compliance

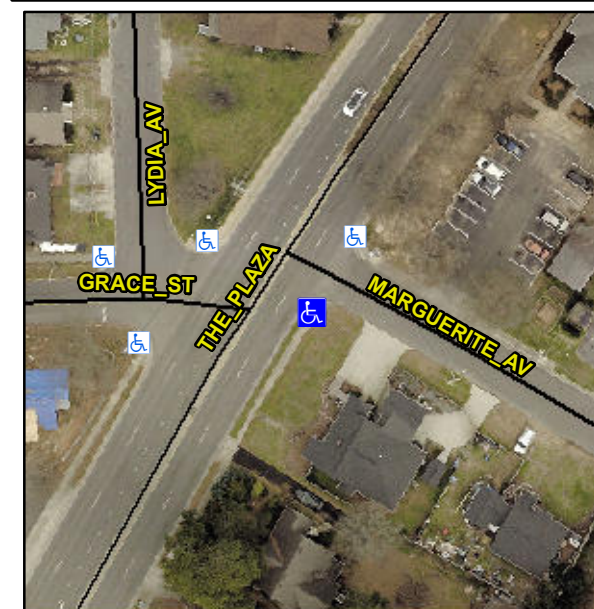
Not Found, R304.5.1, R304.2.2

Compliance	Description	Data	Compliance	Description	Data
N/A	Ramp Length (in)	24.5	No	Ramp Slope (%)	9.4
No	Ramp Width (in)	43.5	Yes	Ramp XSlope (%)	0.4
N/A	Flare Type LT	N/A	N/A	Flare Type RT	N/A
N/A	Flare Slope LT (%)	N/A	N/A	Flare Slope RT (%)	N/A
N/A	Flare Traversable LT?	N/A	N/A	Flare Traversable RT?	N/A
N/A	Landing Length (in)	N/A	N/A	DWS Provided?	N/A
N/A	Landing Width (in)	N/A	N/A	DWS Contrast?	N/A
N/A	Landing Slope (%)	N/A	N/A	DWS Length (in)	N/A
N/A	Landing X Slope (%)	N/A	N/A	DWS Full Width?	N/A
N/A	Landing Curb? (Y/N)	N/A	N/A	DWS Offset (in)	N/A
N/A	Shared Landing?	N/A			
N/A	Gutter Ponding?	N/A	N/A	Gutter Slope (%)	N/A
N/A	Gutter Lip Ht (in)	N/A	N/A	Gutter X Slope (%)	N/A
N/A	Painted X Walk1?	No	N/A	Painted X Walk2?	N/A
	X Walk 1 Direction	To NE		X Walk 2 Direction	N/A
N/A	X Walk 1 Width (in)	N/A	N/A	X Walk 2 Width (in)	N/A
	X Walk 1 Slope (%)	3.3		X Walk 2 Slope (%)	N/A
	X Walk 1 X Slope (%)	1.1		X Walk 2 X Slope (%)	N/A

Possible Solutions:

Remove & Replace Entire Ramp.
