# Access Compliance Report

## Public Rights-of-Way

### (Curb Ramps)

Intersection ID: 32319	Main Street: ARDREY_KELL_RD	Cross Street: BRIDGEVIEW_LN	Location: NW
ADA ID: 827BDD3DDBF5	Ramp Type: Perp	Initial Pass/Fail: Fail	Overall Compliance: No
			Severity Score: 13.75

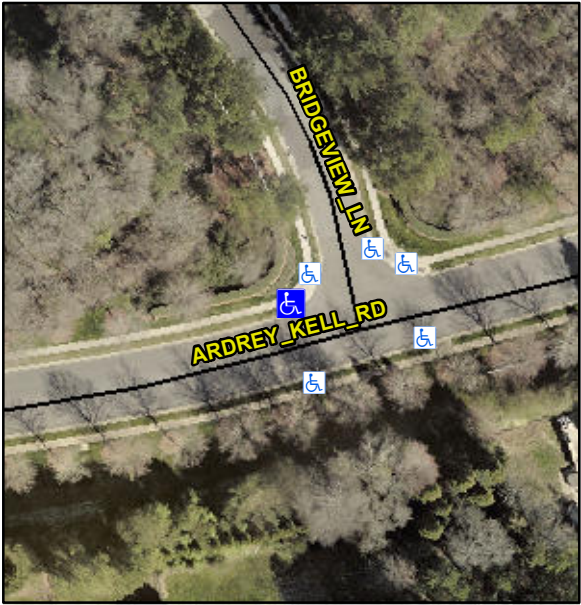
Possible Solutions:		<b>Compliance</b>	<b>Description</b>	<b>Data</b>
	<b>Remove &amp; Replace Entire Ramp.</b>		<b>No</b>	Ramp Length (in)	50.5
			<b>Yes</b>	Ramp Width (in)	61.0
			<b>N/A</b>	Flare Type LT	N/A
			<b>N/A</b>	Flare Slope LT (%)	N/A
			<b>N/A</b>	Flare Traversable LT?	N/A
			<b>N/A</b>	Landing Length (in)	N/A
			<b>N/A</b>	Landing Width (in)	N/A
			<b>N/A</b>	Landing Slope (%)	N/A
			<b>N/A</b>	Landing X Slope (%)	N/A
<p>Surveyor Notes:</p> <p><b>N/A</b></p> <p>PROW/ADA:</p> <p><b>Not Found, R304.2.2, R304.5.3</b></p>			<b>N/A</b>	Flare Type RT	N/A
			<b>N/A</b>	Flare Slope RT (%)	N/A
			<b>N/A</b>	Flare Traversable RT?	N/A
			<b>N/A</b>	DWS Provided?	N/A
			<b>N/A</b>	DWS Contrast?	N/A
			<b>N/A</b>	DWS Length (in)	N/A
			<b>N/A</b>	DWS Full Width?	N/A
			<b>N/A</b>	DWS Offset (in)	N/A
			<b>N/A</b>	Shared Landing?	N/A

<b>N/A</b>	Gutter Ponding?	N/A
			<b>N/A</b>	Gutter Lip Ht (in)	N/A
			<b>No</b>	Painted X Walk1?	N/A
				X Walk 1 Direction	To S
			<b>N/A</b>	X Walk 1 Width (in)	N/A
			<b>4.2</b>	X Walk 1 Slope (%)	N/A
			<b>2.3</b>	X Walk 1 X Slope (%)	N/A
			<b>N/A</b>	Ramp inside XWalk1?	N/A
			<b>N/A</b>	Road Slope (%)	N/A
			<b>N/A</b>	Road X Slope (%)	N/A
			<b>N/A</b>	Any Obstructions?	N/A
				Obstruction Type	
			<b>N/A</b>		
			<b>N/A</b>		
			<b>N/A</b>		
			<b>N/A</b>		
			<b>N/A</b>		
			<b>N/A</b>		
			<b>N/A</b>		
			<b>N/A</b>		
			<b>N/A</b>		
Total Cost:		\$ 1850.00			
			<b>N/A</b>		
			<b>Yes</b>	Surface Condition? (G/P)	Good
