Access Compliance Report

Public Rights-of-Way

(Curb Ramps)

Intersection ID: 44001	Main Street: ELROSE_PL	Cross Street: N/A	Location: SW
ADA ID: 8280F80F12B9	Ramp Type: Perp	Initial Pass/Fail: Fail	Overall Compliance: No
Severity Score: 30			
Codes/Mitigation Info/Possible Solution		Field Measurements/Component Compliance

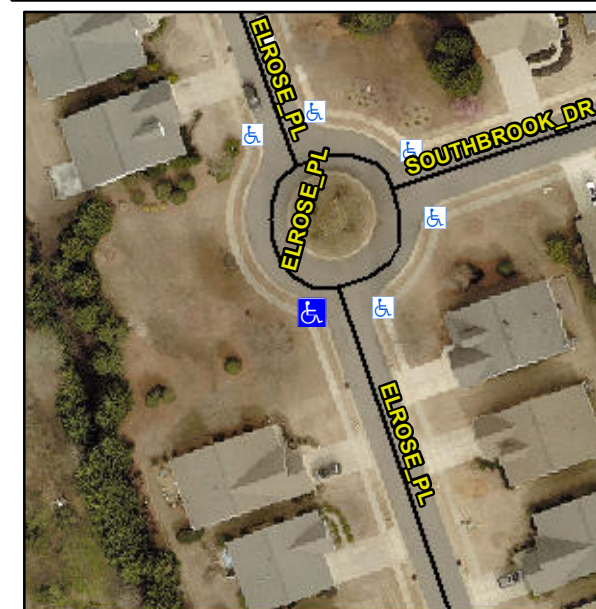
Not Found, R304.5.1, R304.5.3

Compliance	Description	Data	Compliance	Description	Data
N/A	Ramp Length (in)	100.0	Yes	Ramp Slope (%)	7.2
No	Ramp Width (in)	33.0	No	Ramp XSlope (%)	5.5
N/A	Flare Type LT	N/A	N/A	Flare Type RT	N/A
N/A	Flare Slope LT (%)	N/A	N/A	Flare Slope RT (%)	N/A
N/A	Flare Traversable LT?	N/A	N/A	Flare Traversable RT?	N/A
N/A	Landing Length (in)	N/A	N/A	DWS Provided?	N/A
N/A	Landing Width (in)	N/A	N/A	DWS Contrast?	N/A
N/A	Landing Slope (%)	N/A	N/A	DWS Length (in)	N/A
N/A	Landing X Slope (%)	N/A	N/A	DWS Full Width?	N/A
N/A	Landing Curb? (Y/N)	N/A	N/A	DWS Offset (in)	N/A
N/A	Shared Landing?	N/A			
N/A	Gutter Ponding?	N/A	N/A	Gutter Slope (%)	N/A
N/A	Gutter Lip Ht (in)	N/A	N/A	Gutter X Slope (%)	N/A
N/A	Painted X Walk1?	No	N/A	Painted X Walk2?	N/A
	X Walk 1 Direction	To E		X Walk 2 Direction	N/A
N/A	X Walk 1 Width (in)	N/A	N/A	X Walk 2 Width (in)	N/A
	X Walk 1 Slope (%)	0.3		X Walk 2 Slope (%)	N/A
	X Walk 1 X Slope (%)	5.5		X Walk 2 X Slope (%)	N/A

Remove & Replace Entire Ramp.

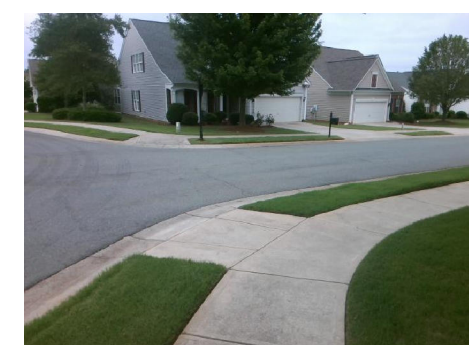
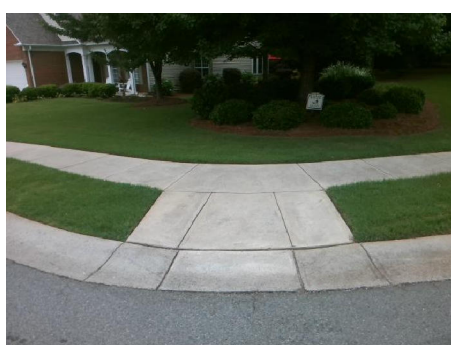
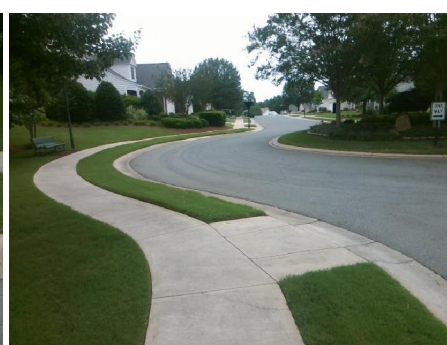
N/A	Ramp inside XWalk1?	N/A	N/A	Ramp inside XWalk2?	N/A
	Road Slope (%)	N/A	N/A	Clear Space?	N/A
	Road X Slope (%)	N/A	N/A	Clear Space to XWalk (in)	N/A
N/A	Any Obstructions?	N/A	N/A	Storm Grate/Utility Hazard?	N/A
	Obstruction Type			Storm Grate/Utility Type	
		N/A			N/A
			Yes	Surface Condition? (G/P)	Good
