Access Compliance Report

Public Rights-of-Way

(Curb Ramps)

Intersection ID: 30541	Main Street: GREENWAY_BEND_DR	Cross Street: SUMMERHILL_RIDGE_DR	Location: SE
ADA ID: 8281151C1A1D	Ramp Type: PerpDiag	Initial Pass/Fail: Fail	Overall Compliance: No
Codes/Mitigation Info/Possible Solution		Field Measurements/Component Compliance

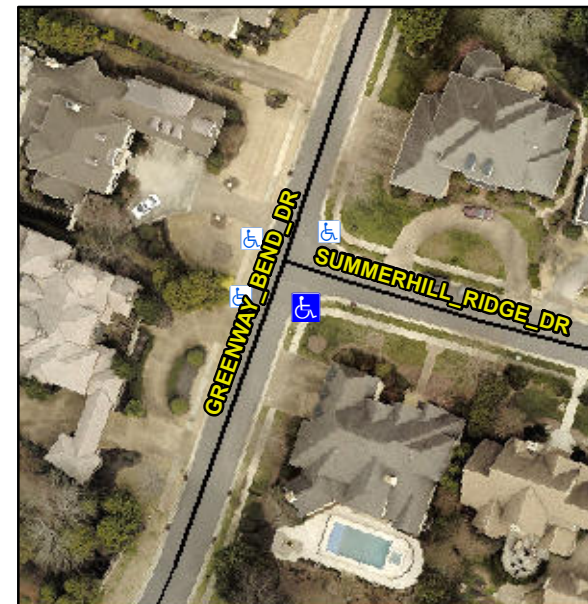
Not Found, R304.2.2, R304.5.3

Compliance	Description	Data	Compliance	Description	Data
N/A	Ramp Length (in)	48.0	No	Ramp Slope (%)	9.3
Yes	Ramp Width (in)	49.0	No	Ramp XSlope (%)	3.7
N/A	Flare Type LT	N/A	N/A	Flare Type RT	N/A
N/A	Flare Slope LT (%)	N/A	N/A	Flare Slope RT (%)	N/A
N/A	Flare Traversable LT?	N/A	N/A	Flare Traversable RT?	N/A
N/A	Landing Length (in)	N/A	N/A	DWS Provided?	N/A
N/A	Landing Width (in)	N/A	N/A	DWS Contrast?	N/A
N/A	Landing Slope (%)	N/A	N/A	DWS Length (in)	N/A
N/A	Landing X Slope (%)	N/A	N/A	DWS Full Width?	N/A
N/A	Landing Curb? (Y/N)	N/A	N/A	DWS Offset (in)	N/A
N/A	Shared Landing?	N/A			
N/A	Gutter Ponding?	N/A	N/A	Gutter Slope (%)	N/A
N/A	Gutter Lip Ht (in)	N/A	N/A	Gutter X Slope (%)	N/A
N/A	Painted X Walk1?	No	N/A	Painted X Walk2?	No
	X Walk 1 Direction	To NE		X Walk 2 Direction	To NW
N/A	X Walk 1 Width (in)	N/A	N/A	X Walk 2 Width (in)	N/A
	X Walk 1 Slope (%)	4.9		X Walk 2 Slope (%)	2.3
	X Walk 1 X Slope (%)	0.0		X Walk 2 X Slope (%)	2.3

N/A	Ramp inside XWalk1?	N/A	N/A	Ramp inside XWalk2?	N/A
	Road Slope (%)	1.1	N/A	Clear Space?	N/A
	Road X Slope (%)	4.5	N/A	Clear Space to XWalk (in)	N/A
N/A	Any Obstructions?	N/A	N/A	Storm Grate/Utility Hazard?	N/A
	Obstruction Type			Storm Grate/Utility Type	
		N/A			N/A
			Yes	Surface Condition? (G/P)	Good

Remove & Replace Curb Ramp With Two New Directional Ramps or Equivalent.
