Access Compliance Report

Public Rights-of-Way

(Curb Ramps)

Intersection ID: 47115	Main Street: CARPENTER_CABIN_DR	Cross Street: TINDLE_HILL_LN	Location: S
ADA ID: 829B246977AE	Ramp Type: BlendTrans1	Initial Pass/Fail: Fail	Overall Compliance: No
		Severity Score: 25

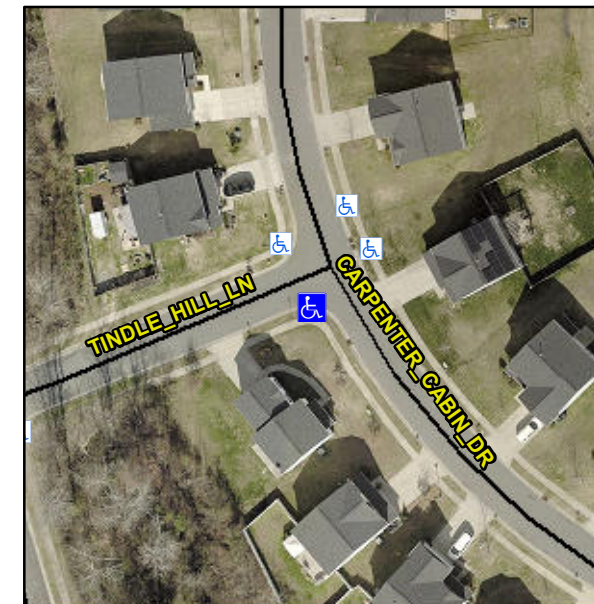
Compliance	Description	Data	Compliance	Description	Data
N/A	Ramp Length (in)	48.0	Yes	BlendTrans Slope (%)	3.7
Yes	Ramp Width (in)	48.0	No	BlendTrans XSlope (%)	7.9
N/A	Flare Type LT	N/A	N/A	Flare Type RT	N/A
N/A	Flare Slope LT (%)	N/A	N/A	Flare Slope RT (%)	N/A
N/A	Flare Traversable LT?	N/A	N/A	Flare Traversable RT?	N/A
N/A	Landing Length (in)	N/A	N/A	DWS Provided?	N/A
N/A	Landing Width (in)	N/A	N/A	DWS Contrast?	N/A
N/A	Landing Slope (%)	N/A	N/A	DWS Length (in)	N/A
N/A	Landing X Slope (%)	N/A	N/A	DWS Full Width?	N/A
N/A	Landing Curb? (Y/N)	N/A	N/A	DWS Offset (in)	N/A
N/A	Shared Landing?	N/A			
N/A	Gutter Ponding?	N/A	N/A	Gutter Slope (%)	N/A
N/A	Gutter Lip Ht (in)	N/A	N/A	Gutter X Slope (%)	N/A
N/A	Painted X Walk1?	No	N/A	Painted X Walk2?	No
	X Walk 1 Direction	To NW		X Walk 2 Direction	To NE
	X Walk 1 Width (in)	N/A		X Walk 2 Width (in)	N/A
	X Walk 1 Slope (%)	2.1		X Walk 2 Slope (%)	1.8
	X Walk 1 X Slope (%)	0.7		X Walk 2 X Slope (%)	4.3

N/A	Ramp inside XWalk1?	N/A	N/A	Ramp inside XWalk2?	N/A
	Road Slope (%)	4.6		Clear Space?	N/A
	Road X Slope (%)	3.4	N/A	Clear Space to XWalk (in)	N/A
N/A	Any Obstructions?	N/A	N/A	Storm Grate/Utility Hazard?	N/A
	Obstruction Type			Storm Grate/Utility Type	
		N/A			N/A
			Yes	Surface Condition? (G/P)	Good
			No	Curb Slope (%)	19.8

Remove & Replace Curb Ramp With Two New Directional Ramps or Equivalent.

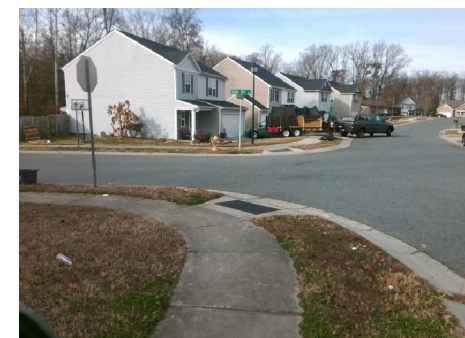
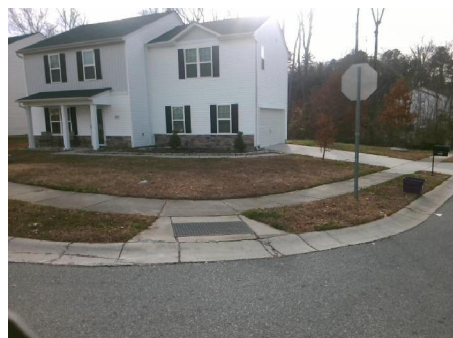
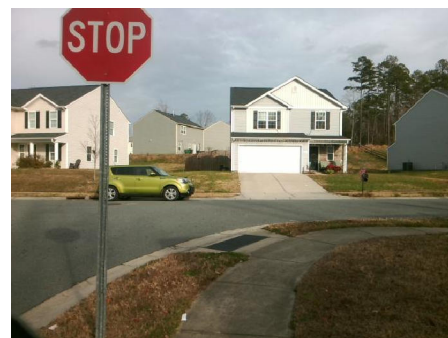
Street 1 Name CARPENTER CABIN DR
 Stop Condition-Street 1 None
 Street 2 Name TINDLE HILL LN
 Stop Condition-Street 2 StopSign
