Access Compliance Report

Public Rights-of-Way

(Curb Ramps)

| ADA ID: 829D5370BF36 | Ramp Type: PerpDiag | Initial Pass/Fail: Fail | Overall Compliance: No |

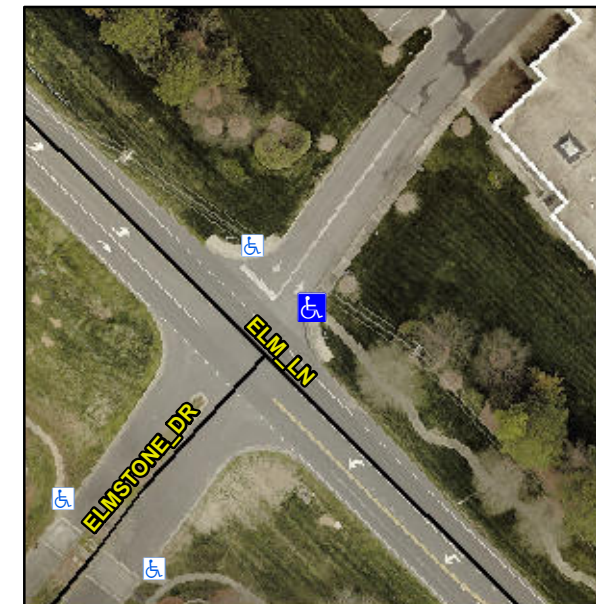
| Severity Score: 33.75 | | | |

R304.5.1, R304.2.2, R304.5.3

| Compliance | Description | Data | Compliance | Description | Data |
|---|---|---|---|---|---|
| N/A | Ramp Length (in) | 62.5 | No | Ramp Slope (%) | 11.7 |
| No | Ramp Width (in) | 43.5 | No | Ramp XSlope (%) | 6.5 |

Remove & Replace Curb Ramp With Two New Directional Ramps or Equivalent.

Total Cost: \$ 3200.00
