Access Compliance Report

Public Rights-of-Way

(Curb Ramps)

Intersection ID: 44015	Main Street: ATWATER_LN	Cross Street: MANTARIO_DR	Location: W
ADA ID: 829E6DC77833	Ramp Type: PerpDiag	Initial Pass/Fail: Fail	Overall Compliance: No
		Severity Score: 42.5

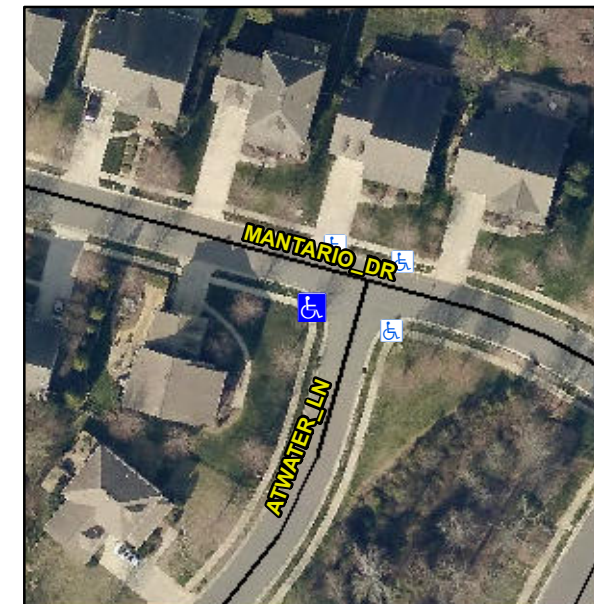
Compliance	Description	Data	Compliance	Description	Data
N/A	Ramp Length (in)	50.0	Yes	Ramp Slope (%)	5.6
No	Ramp Width (in)	35.0	No	Ramp XSlope (%)	8.2
N/A	Flare Type LT	N/A	N/A	Flare Type RT	N/A
N/A	Flare Slope LT (%)	N/A	N/A	Flare Slope RT (%)	N/A
N/A	Flare Traversable LT?	N/A	N/A	Flare Traversable RT?	N/A
N/A	Landing Length (in)	N/A	N/A	DWS Provided?	N/A
N/A	Landing Width (in)	N/A	N/A	DWS Contrast?	N/A
N/A	Landing Slope (%)	N/A	N/A	DWS Length (in)	N/A
N/A	Landing X Slope (%)	N/A	N/A	DWS Full Width?	N/A
N/A	Landing Curb? (Y/N)	N/A	N/A	DWS Offset (in)	N/A
N/A	Shared Landing?	N/A			
N/A	Gutter Ponding?	N/A	N/A	Gutter Slope (%)	N/A
N/A	Gutter Lip Ht (in)	N/A	N/A	Gutter X Slope (%)	N/A
N/A	Painted X Walk1?	No	N/A	Painted X Walk2?	No
	X Walk 1 Direction	To SE		X Walk 2 Direction	To NE
N/A	X Walk 1 Width (in)	N/A	N/A	X Walk 2 Width (in)	N/A
	X Walk 1 Slope (%)	3.5		X Walk 2 Slope (%)	3.1
	X Walk 1 X Slope (%)	4.5		X Walk 2 X Slope (%)	6.0

N/A	Ramp inside XWalk1?	N/A	N/A	Ramp inside XWalk2?	N/A
	Road Slope (%)	6.8	N/A	Clear Space?	N/A
	Road X Slope (%)	0.6	N/A	Clear Space to XWalk (in)	N/A
N/A	Any Obstructions?	N/A	N/A	Storm Grate/Utility Hazard?	N/A
	Obstruction Type			Storm Grate/Utility Type	
		N/A			N/A
			Yes	Surface Condition? (G/P)	Good

Remove & Replace Curb Ramp With Two New Directional Ramps or Equivalent.

R304.5.1, R304.5.3
