## **Access Compliance Report Public Rights-of-Way** (Curb Ramps)

Intersection ID: 19953 Main Street: ARCHDALE\_DR Cross Street: OLD\_PINEVILLE\_RD Location: SE Severity Score: **Overall Compliance: No** ADA ID: 82C3561A1C6A Ramp Type: Perp Initial Pass/Fail: Fail 22.5

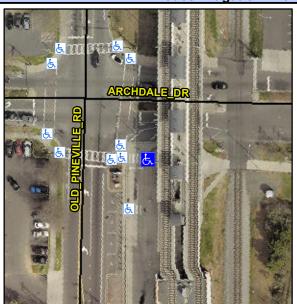
Field Measurements/Component Compliance								
Comp	Compliance Description		Compliance Description		Data			
N/A	Ramp Length (in)	73.0	No	Ramp Slope (%)	8.8			
No	Ramp Width (in)	45.0	No	Ramp XSlope (%)	2.5			
N/A	Flare Type LT	N/A	N/A	Flare Type RT	N/A			
N/A	Flare Slope LT (%)	N/A	N/A	Flare Slope RT (%)	N/A			
N/A	Flare Traversable LT?	N/A	N/A	Flare Traversable RT?	N/A			
N/A	Landing Length (in)	N/A	N/A	DWS Provided?	N/A			
N/A	Landing Width (in)	N/A	N/A	DWS Contrast?	N/A			
N/A	Landing Slope (%)	N/A	N/A	DWS Length (in)	N/A			
N/A	Landing X Slope (%)	N/A	N/A	DWS Full Width?	N/A			
N/A	Landing Curb? (Y/N)	N/A	N/A	DWS Offset (in)	N/A			
N/A	Shared Landing?	N/A						
N/A	Gutter Ponding?	N/A	N/A	Gutter Slope (%)	N/A			
N/A	Gutter Lip Ht (in)	N/A	N/A	Gutter X Slope (%)	N/A			
N/A	Painted X Walk1?	Yes	N/A	Painted X Walk2?	N/A			
	X Walk 1 Direction	To W		X Walk 2 Direction	N/A			
N/A	X Walk 1 Width (in)	120.0	N/A	X Walk 2 Width (in)	N/A

X Walk 1 Slope (%)	2.8		X Walk 2 Slope (%)	N/A			
	X Walk 1 X Slope (%)	1.8		X Walk 2 X Slope (%)	N/A			
N/A	Ramp inside XWalk1?	Yes	N/A	Ramp inside XWalk2?	N/A			
	Road Slope (%)	N/A	N/A	Clear Space?	N/A			
	Road X Slope (%)	N/A	N/A	Clear Space to XWalk (in)	N/A			
N/A	Any Obstructions?	N/A	N/A	Storm Grate/Utility Hazard?	N/A			
	Obstruction Type			Storm Grate/Utility Type				
		N/A			N/A			
			Yes	Surface Condition? (G/P)	Good

Sec. 1	Possible Solutions:
1	Remove & Replace Entire Ramp.
e e	
1	
100	Surveyor Notes:
100	N/A
-	
-	
6	
3	PROW/ADA:
	Not Found, R304.5.1, R304.2.2,
No. of Street, or other Persons and the Person	R304.5.3
1

Total Cost:	\$ 1850.00
