Access Compliance Report

Public Rights-of-Way

(Curb Ramps)

Intersection ID: 16396	Main Street: BEAL_ST	Cross Street: N_WENDOVER_RD	Location: N
ADA ID: 82C50D9A654E	Ramp Type: PerpDiag	Initial Pass/Fail: Fail	Overall Compliance: No
		Severity Score: 12.5

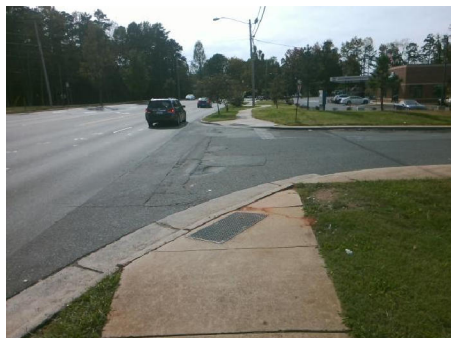
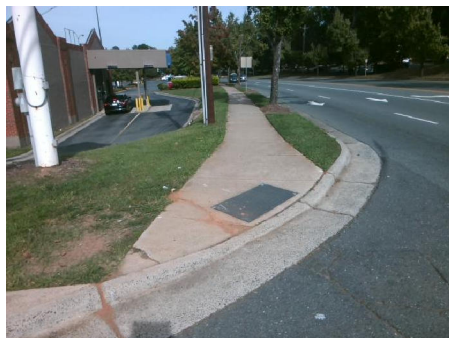
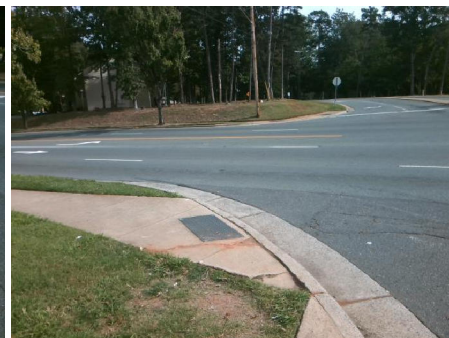
Not Found, R304.2.2

Compliance	Description	Data	Compliance	Description	Data
N/A	Ramp Length (in)	62.0	No	Ramp Slope (%)	8.6
Yes	Ramp Width (in)	48.0	Yes	Ramp XSlope (%)	0.6
N/A	Flare Type LT	N/A	N/A	Flare Type RT	N/A
N/A	Flare Slope LT (%)	N/A	N/A	Flare Slope RT (%)	N/A
N/A	Flare Traversable LT?	N/A	N/A	Flare Traversable RT?	N/A
N/A	Landing Length (in)	N/A	N/A	DWS Provided?	N/A
N/A	Landing Width (in)	N/A	N/A	DWS Contrast?	N/A
N/A	Landing Slope (%)	N/A	N/A	DWS Length (in)	N/A
N/A	Landing X Slope (%)	N/A	N/A	DWS Full Width?	N/A
N/A	Landing Curb? (Y/N)	N/A	N/A	DWS Offset (in)	N/A
N/A	Shared Landing?	N/A			
N/A	Gutter Ponding?	N/A	N/A	Gutter Slope (%)	N/A
N/A	Gutter Lip Ht (in)	2.0	N/A	Gutter X Slope (%)	N/A
N/A	Painted X Walk1?	No	N/A	Painted X Walk2?	No
	X Walk 1 Direction	To SW		X Walk 2 Direction	To SE
N/A	X Walk 1 Width (in)	N/A	N/A	X Walk 2 Width (in)	N/A
	X Walk 1 Slope (%)	0.6		X Walk 2 Slope (%)	2.1
	X Walk 1 X Slope (%)	0.4		X Walk 2 X Slope (%)	1.4

N/A	Ramp inside XWalk1?	N/A	N/A	Ramp inside XWalk2?	N/A
	Road Slope (%)	0.5	N/A	Clear Space?	N/A
	Road X Slope (%)	0.4	N/A	Clear Space to XWalk (in)	N/A
N/A	Any Obstructions?	N/A	N/A	Storm Grate/Utility Hazard?	N/A
	Obstruction Type			Storm Grate/Utility Type	
		N/A			N/A
			Yes	Surface Condition? (G/P)	Good

Remove & Replace Curb Ramp With Two New Directional Ramps or Equivalent.
