Access Compliance Report

Public Rights-of-Way

(Curb Ramps)

Intersection ID: 10028419	Main Street: HIGHGROVE_ST	Cross Street: N/A	Location: NW
ADA ID: 82C7E1BA29EA	Ramp Type: PerpDiag	Initial Pass/Fail: Fail	Overall Compliance: No
		Severity Score: 22.5

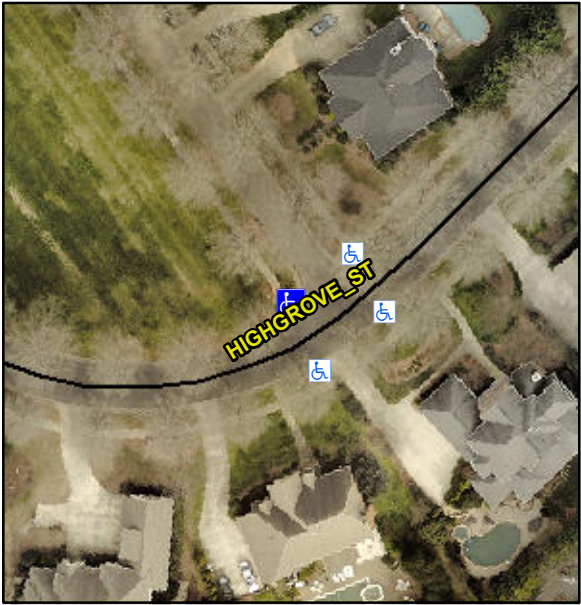
N/A	DWS Provided?	N/A
			N/A	DWS Contrast?	N/A
			N/A	DWS Length (in)	N/A
			N/A	DWS Full Width?	N/A
			N/A	DWS Offset (in)	N/A
			N/A	Gutter Slope (%)	N/A
			N/A	Gutter X Slope (%)	N/A
			N/A	Painted X Walk2?	No
				X Walk 2 Direction	To NE
			N/A	X Walk 2 Width (in)	N/A
				X Walk 2 Slope (%)	2.6
				X Walk 2 X Slope (%)	1.0
			N/A	Ramp inside XWalk2?	N/A
			N/A	Clear Space?	N/A
			N/A	Clear Space to XWalk (in)	N/A
			N/A	Storm Grate/Utility Hazard?	N/A
				Storm Grate/Utility Type	
			N/A		N/A
			Yes	Surface Condition? (G/P)	Good
Street 1 Name	HIGHGROVE ST				
Stop Condition-Street 2	None				
Street 2 Name	HIGHGROVE ST				
Stop Condition-Street 1	StopSign				
Total Cost:	\$	3200.00

Possible Solutions:		Compliance	Description	Data
	Remove & Replace Curb Ramp With Two New Directional Ramps or Equivalent.		No	Ramp Length (in)	96.0
			No	Ramp Width (in)	46.5
			N/A	Flare Type LT	N/A
			N/A	Flare Slope LT (%)	N/A
			N/A	Flare Traversable LT?	N/A
			N/A	Landing Length (in)	N/A
			N/A	Landing Width (in)	N/A
			N/A	Landing Slope (%)	N/A
			N/A	Landing X Slope (%)	N/A
			N/A	Landing Curb? (Y/N)	N/A
			N/A	Shared Landing?	N/A
			N/A	Gutter Ponding?	N/A
			N/A	Gutter Lip Ht (in)	N/A
			No	Painted X Walk1?	No
				X Walk 1 Direction	To S
			N/A	X Walk 1 Width (in)	N/A
				X Walk 1 Slope (%)	5.2
				X Walk 1 X Slope (%)	0.7
			N/A	Ramp inside XWalk1?	N/A
<p>Surveyor Notes:</p> <p>N/A</p> <p>PROW/ADA:</p> <p>R304.5.1, R304.2.2, R304.5.3</p>			N/A	Flare Type RT	N/A
			N/A	Flare Slope RT (%)	N/A
			N/A	Flare Traversable RT?	N/A
