# Access Compliance Report

## Public Rights-of-Way

### (Curb Ramps)

Intersection ID: 15397	Main Street: N_WENDOVER_RD	Cross Street: N_WENDOVER_RD_RA	Location: NE
ADA ID: 82D7DFFA3078	Ramp Type: Perp	Initial Pass/Fail: Fail	Overall Compliance: No
Severity Score: 21.25			
Codes/Mitigation Info/Possible Solution		Field Measurements/Component Compliance

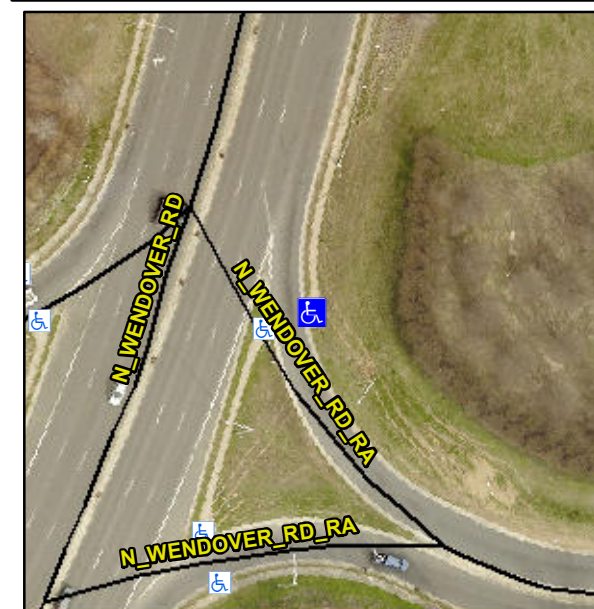
**Not Found, R304.5.1, R304.2.2**

Compliance	Description	Data	Compliance	Description	Data
N/A	Ramp Length (in)	84.0	No	Ramp Slope (%)	8.7
No	Ramp Width (in)	42.0	Yes	Ramp XSlope (%)	1.1
N/A	Flare Type LT	N/A	N/A	Flare Type RT	N/A
N/A	Flare Slope LT (%)	N/A	N/A	Flare Slope RT (%)	N/A
N/A	Flare Traversable LT?	N/A	N/A	Flare Traversable RT?	N/A
N/A	Landing Length (in)	N/A	N/A	DWS Provided?	N/A
N/A	Landing Width (in)	N/A	N/A	DWS Contrast?	N/A
N/A	Landing Slope (%)	N/A	N/A	DWS Length (in)	N/A
N/A	Landing X Slope (%)	N/A	N/A	DWS Full Width?	N/A
N/A	Landing Curb? (Y/N)	N/A	N/A	DWS Offset (in)	N/A
N/A	Shared Landing?	N/A			
N/A	Gutter Ponding?	N/A	N/A	Gutter Slope (%)	N/A
N/A	Gutter Lip Ht (in)	N/A	N/A	Gutter X Slope (%)	N/A
N/A	Painted X Walk1?	No	N/A	Painted X Walk2?	N/A
	X Walk 1 Direction	To SW		X Walk 2 Direction	N/A
N/A	X Walk 1 Width (in)	N/A	N/A	X Walk 2 Width (in)	N/A
	X Walk 1 Slope (%)	1.1		X Walk 2 Slope (%)	N/A
	X Walk 1 X Slope (%)	1.1		X Walk 2 X Slope (%)	N/A

N/A	Ramp inside XWalk1?	N/A	N/A	Ramp inside XWalk2?	N/A
	Road Slope (%)	N/A	N/A	Clear Space?	N/A
	Road X Slope (%)	N/A	N/A	Clear Space to XWalk (in)	N/A
N/A	Any Obstructions?	N/A	N/A	Storm Grate/Utility Hazard?	N/A
	Obstruction Type			Storm Grate/Utility Type	
		N/A			N/A
			Yes	Surface Condition? (G/P)	Good

**Remove & Replace Entire Ramp.**

Total Cost: \$ 1850.00
