# Access Compliance Report

## Public Rights-of-Way

| Intersection ID: 8070 | Main Street: LITTLE ROCK RD | Cross Street: PAW CREEK RD | Location: SE |
| ADA ID: 82E11A951EA7 | Ramp Type: PerpDiag | Initial Pass/Fail: Fail | Overall Compliance: No |

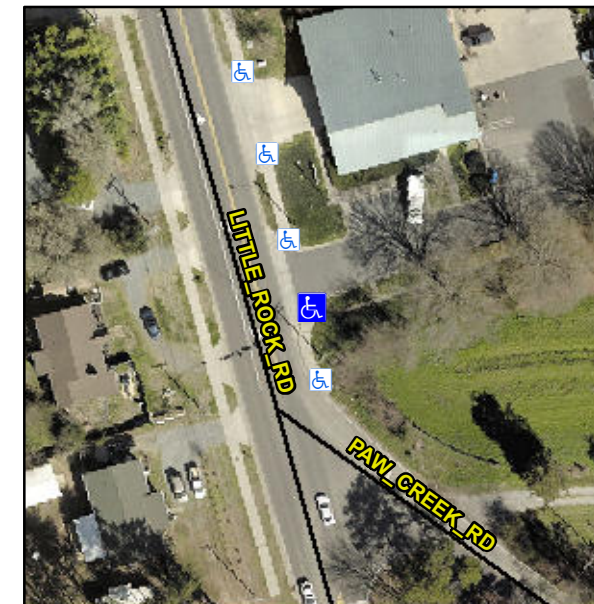
**Not Found, R304.5.1, R304.5.3**

| Compliance | Description | Data | Compliance | Description | Data |
|---|---|---|---|---|---|
| N/A | Ramp Length (in) | 72.0 | Yes | Ramp Slope (%) | 6.0 |
| No | Ramp Width (in) | 46.0 | No | Ramp XSlope (%) | 3.5 |

**Remove & Replace Curb Ramp With Two New Directional Ramps or Equivalent.**
