Access Compliance Report Public Rights-of-Way (Curb Ramps)

Intersection ID: 51058	section ID: 51058 Main Street: CRAIGMOSS_LN			Street:	SHOPTON_RD_WES	Location:	SW		
ADA ID: 82EA743091DF	82EA743091DF Ramp Type: PerpDiag			Pass/Fa	ail: Fail Overall	o Severity Score:	21.25		
Codes/Mitigation Info/Possible Solution				Field Measurements/Component Compliance					
(a + 17 9		Possible Solutions:		Compliance Description			Data Compliance Description		
and the second	and all	Remove & Replace Curb Ramp V	Nith	N/A	Ramp Length (in)	69.0	No	Ramp Slope (%)	10.6
		Two New Directional Ramps or		No	Ramp Width (in)	40.0		Ramp XSlope (%)	2.0
		Equivalent.		N/A	Flare Type LT	N/A	N/A	Flare Type RT	N/A

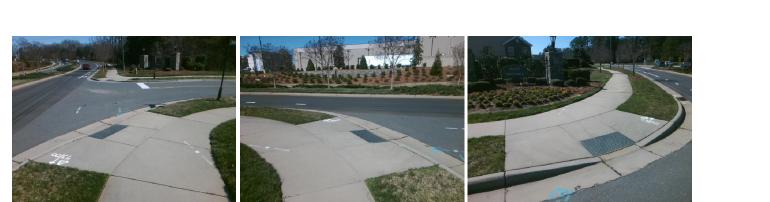
- Destroy data	and the second second			N/A	Flare Slope LT (%)	N/A	N/A	Flare Slope RT (%)	N/A
SHOPTON	P.WEST	1		N/A	Flare Traversable LT?	N/A	N/A	Flare Traversable RT?	N/A
		5		N/A	Landing Length (in)	N/A	N/A	DWS Provided?	N/A
		Surveyor Notes:		N/A	Landing Width (in)	N/A	N/A	DWS Contrast?	N/A
the second states of the		N/A		N/A	Landing Slope (%)	N/A	N/A	DWS Length (in)	N/A
				N/A	Landing X Slope (%)	N/A	N/A	DWS Full Width?	N/A
+ 3K 40	1 and and			N/A	Landing Curb? (Y/N)	N/A	N/A	DWS Offset (in)	N/A
16	A RAN MARTINE			N/A	Shared Landing?	N/A		ζ,	
CERT CERT	A Barriston	PROW/ADA:		N/A	Gutter Ponding?	N/A	N/A	Gutter Slope (%)	N/A
MELLEC		R304.5.1, R304.2.2		N/A	Gutter Lip Ht (in)	N/A	N/A	Gutter X Slope (%)	N/A
Git				N/A	Painted X Walk1?	No	N/A	Painted X Walk2?	No

- And -					X Walk 1 Direction	To SE		X Walk 2 Direction	To NE
	No. of Street of			N/A	X Walk 1 Width (in)	N/A	N/A	X Walk 2 Width (in)	N/A
Street 1 Name	CRAIGMOSS LN	-			X Walk 1 Slope (%)	0.3		X Walk 2 Slope (%)	4.7
Stop Condition-Street 2	StopSign				X Walk 1 X Slope (%)	2.0		X Walk 2 X Slope (%)	2.2
Street 2 Name	SHOPTON RD WEST			N/A	Ramp inside XWalk1?	N/A	N/A	Ramp inside XWalk2?	N/A
Stop Condition-Street 1	None				Road Slope (%)	2.0	N/A	Clear Space?	N/A
					Road X Slope (%)	0.8	N/A	Clear Space to XWalk (in)	N/A
				N/A	Any Obstructions?	N/A	N/A	Storm Grate/Utility Hazard?	N/A
		Total Cost: \$	3200.00		Obstruction Type			Storm Grate/Utility Type	
						N/A			N/A

Yes Surface Condition? (G/P) Good
