Access Compliance Report

Public Rights-of-Way

(Curb Ramps)

Intersection ID: 22684	Main Street: OUTER_BRIDGE_LN	Cross Street: OXWYNN_LN	Location: NW
ADA ID: 82F2EEF3CD2B	Ramp Type: PerpDiag	Initial Pass/Fail: Fail	Overall Compliance: No
Severity Score: 26.25			
Codes/Mitigation Info/Possible Solution		Field Measurements/Component Compliance

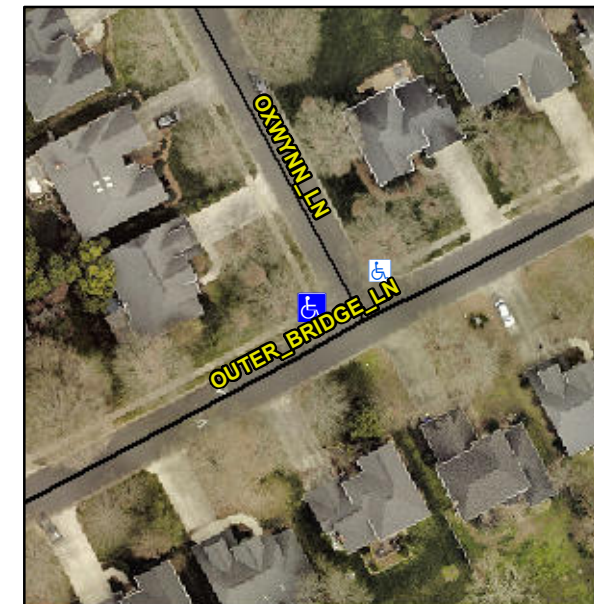
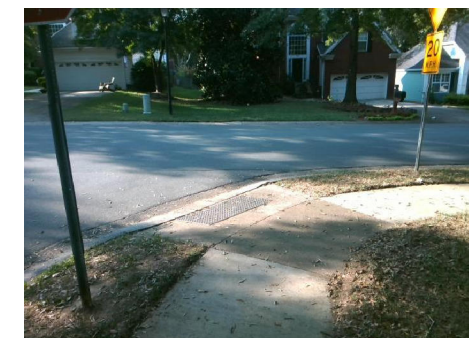
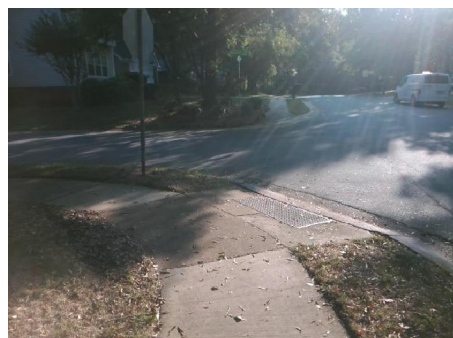
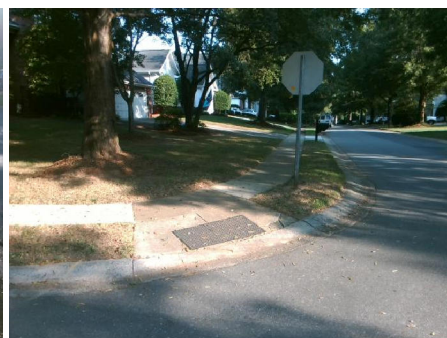
Not Found, R304.2.2, R304.5.3

Compliance	Description	Data	Compliance	Description	Data
N/A	Ramp Length (in)	45.0	No	Ramp Slope (%)	13.5
Yes	Ramp Width (in)	48.0	No	Ramp XSlope (%)	4.9
N/A	Flare Type LT	N/A	N/A	Flare Type RT	N/A
N/A	Flare Slope LT (%)	N/A	N/A	Flare Slope RT (%)	N/A
N/A	Flare Traversable LT?	N/A	N/A	Flare Traversable RT?	N/A
N/A	Landing Length (in)	N/A	N/A	DWS Provided?	N/A
N/A	Landing Width (in)	N/A	N/A	DWS Contrast?	N/A
N/A	Landing Slope (%)	N/A	N/A	DWS Length (in)	N/A
N/A	Landing X Slope (%)	N/A	N/A	DWS Full Width?	N/A
N/A	Landing Curb? (Y/N)	N/A	N/A	DWS Offset (in)	N/A
N/A	Shared Landing?	N/A			
N/A	Gutter Ponding?	N/A	N/A	Gutter Slope (%)	N/A
N/A	Gutter Lip Ht (in)	N/A	N/A	Gutter X Slope (%)	N/A
N/A	Painted X Walk1?	No	N/A	Painted X Walk2?	No
	X Walk 1 Direction	To S		X Walk 2 Direction	To E
N/A	X Walk 1 Width (in)	N/A	N/A	X Walk 2 Width (in)	N/A
	X Walk 1 Slope (%)	1.9		X Walk 2 Slope (%)	4.2
	X Walk 1 X Slope (%)	3.3		X Walk 2 X Slope (%)	2.3

N/A	Ramp inside XWalk1?	N/A	N/A	Ramp inside XWalk2?	N/A
	Road Slope (%)	1.9	N/A	Clear Space?	N/A
	Road X Slope (%)	5.5	N/A	Clear Space to XWalk (in)	N/A
N/A	Any Obstructions?	N/A	N/A	Storm Grate/Utility Hazard?	N/A
	Obstruction Type			Storm Grate/Utility Type	
		N/A			N/A
		Yes		Surface Condition? (G/P)	Good

Remove & Replace Curb Ramp With Two New Directional Ramps or Equivalent.
