Access Compliance Report Public Rights-of-Way (Curb Ramps)

Intersection ID: 20933 Main Street: OLD_FARM_RD Cross Street: PROVIDENCE_RD Location: SW

ADA ID: 82F80BC8BF12 Ramp Type: PerpDiag Initial Pass/Fail: Fail Overall Compliance: No Severity Score: 25

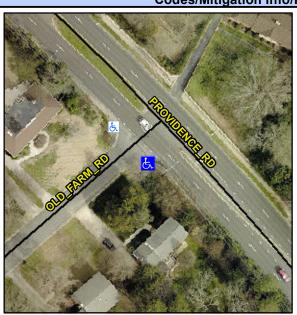
r leid Measurements/Component Compnance						
	Compliance Description		Data	Compliance Description		Data
	N/A	Ramp Length (in)	57.0	No	Ramp Slope (%)	13.3
	Yes	Ramp Width (in)	48.0	Yes	Ramp XSlope (%)	0.6
	N/A	Flare Type LT	N/A	N/A	Flare Type RT	N/A
	N/A	Flare Slope LT (%)	N/A	N/A	Flare Slope RT (%)	N/A
	N/A	Flare Traversable LT?	N/A	N/A	Flare Traversable RT?	N/A
	N/A	Landing Length (in)	N/A	N/A	DWS Provided?	N/A
	N/A	Landing Width (in)	N/A	N/A	DWS Contrast?	N/A
	N/A	Landing Slope (%)	N/A	N/A	DWS Length (in)	N/A
	N/A	Landing X Slope (%)	N/A	N/A	DWS Full Width?	N/A
	N/A	Landing Curb? (Y/N)	N/A	N/A	DWS Offset (in)	N/A
	N/A	Shared Landing?	N/A			
	N/A	Gutter Ponding?	N/A	N/A	Gutter Slope (%)	N/A
	N/A	Gutter Lip Ht (in)	N/A	N/A	Gutter X Slope (%)	N/A
	N/A	Painted X Walk1?	No	N/A	Painted X Walk2?	No
		X Walk 1 Direction	To NE		X Walk 2 Direction	To NW
	N/A	X Walk 1 Width (in)	N/A	N/A	X Walk 2 Width (in)	N/A
		X Walk 1 Slope (%)	0.1		X Walk 2 Slope (%)	0.3

X Walk 1 X Slope (%)	1.3		X Walk 2 X Slope (%)	1.4
	N/A	Ramp inside XWalk1?	N/A	N/A	Ramp inside XWalk2?	N/A
		Road Slope (%)	1.0	N/A	Clear Space?	N/A
		Road X Slope (%)	0.6	N/A	Clear Space to XWalk (in)	N/A
	N/A	Any Obstructions?	N/A	N/A	Storm Grate/Utility Hazard?	N/A
		Obstruction Type			Storm Grate/Utility Type

Remove & Replace Curb Ramp With
Two New Directional Ramps or
Equivalent.

PROW/ADA:
Not Found, R304.2.2
