Access Compliance Report Public Rights-of-Way (Curb Ramps)

Intersection ID: 18533 Main Street: FAIRFAX DR Cross Street: MICHAEL BAKER PL Location: NW **Severity Score:** ADA ID: 82FA3759FBB1 Ramp Type: PerpDiag Initial Pass/Fail: Fail **Overall Compliance: No** 35

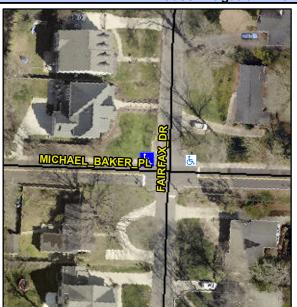
| Field Measurements/Component Compliance | | | | | |
|---|---|---|---|---|---|
| N/A | Ramp Length (in) | 52.0 | No | Ramp Slope (%) | 15.5 |
| No | Ramp Width (in) | 37.0 | No | Ramp XSlope (%) | 2.1 |

MICHAEL BAKER PL Street 1 Name Stop Condition-Street 2 StopSign Street 2 Name **FAIRFAX DR** Stop Condition-Street 1 StopSign Possible Solutions: Remove & Replace Curb Ramp With **Two New Directional Ramps or** Equivalent. Surveyor Notes: N/A PROW/ADA: Not Found, R304.5.1, R304.2.2, R304.5.3
