## **Access Compliance Report Public Rights-of-Way** (Curb Ramps)

Intersection ID: 11225 Main Street: ELKWOOD\_CR Cross Street: SHAMROCK\_DR Location: W Severity Score: **Overall Compliance: No** ADA ID: 830627C86F48 Ramp Type: Perp Initial Pass/Fail: Fail 22.5

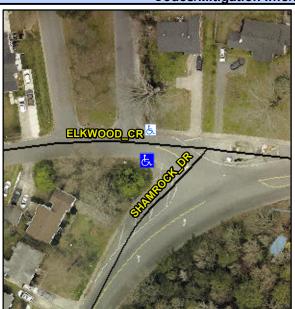
Field Measurements/Component Compliance							
Comp	liance Description	Data	Comp	liance Description	Data		
N/A	Ramp Length (in)	56.0	No	Ramp Slope (%)	9.0		
No	Ramp Width (in)	46.0	No	Ramp XSlope (%)	3.3		
N/A	Flare Type LT	N/A	N/A	Flare Type RT	N/A		
N/A	Flare Slope LT (%)	N/A	N/A	Flare Slope RT (%)	N/A		
N/A	Flare Traversable LT?	N/A	N/A	Flare Traversable RT?	N/A		
N/A	Landing Length (in)	N/A	N/A	DWS Provided?	N/A		
N/A	Landing Width (in)	N/A	N/A	DWS Contrast?	N/A		
N/A	Landing Slope (%)	N/A	N/A	DWS Length (in)	N/A		
N/A	Landing X Slope (%)	N/A	N/A	DWS Full Width?	N/A		
N/A	Landing Curb? (Y/N)	N/A	N/A	DWS Offset (in)	N/A		
N/A	Shared Landing?	N/A					
N/A	Gutter Ponding?	N/A	N/A	Gutter Slope (%)	N/A		
N/A	Gutter Lip Ht (in)	N/A	N/A	Gutter X Slope (%)	N/A		
N/A	Painted X Walk1?	No	N/A	Painted X Walk2?	N/A		
	X Walk 1 Direction	To NE		X Walk 2 Direction	N/A		
N/A	X Walk 1 Width (in)	N/A	N/A	X Walk 2 Width (in)	N/A

X Walk 1 Slope (%)	2.2		X Walk 2 Slope (%)	N/A		
	X Walk 1 X Slope (%)	0.8		X Walk 2 X Slope (%)	N/A		
N/A	Ramp inside XWalk1?	N/A	N/A	Ramp inside XWalk2?	N/A		
	Road Slope (%)	N/A	N/A	Clear Space?	N/A		
	Road X Slope (%)	N/A	N/A	Clear Space to XWalk (in)	N/A		
N/A	Any Obstructions?	N/A	N/A	Storm Grate/Utility Hazard?	N/A		
	Obstruction Type			Storm Grate/Utility Type			
		N/A			N/A		
			Yes	Surface Condition? (G/P)	Good

1 CCCIDIC CCIGGICI	
Possible Solutions:	
Remove & Replace Entire Ramp.	
	I
Surveyor Notes:	
N/A	
PROW/ADA:	
Not Found, R304.5.1, R304.2.2,	
R304.5.3

Total Cost:	\$ 1850.00
