# Access Compliance Report

## Public Rights-of-Way

### (Curb Ramps)

Intersection ID: 14704	Main Street: BELGRAVE_PL	Cross Street: ROMANY_RD	Location: NE
ADA ID: 831A7689B5A3	Ramp Type: PerpDiag	Initial Pass/Fail: Fail	Overall Compliance: No
		Severity Score: 25

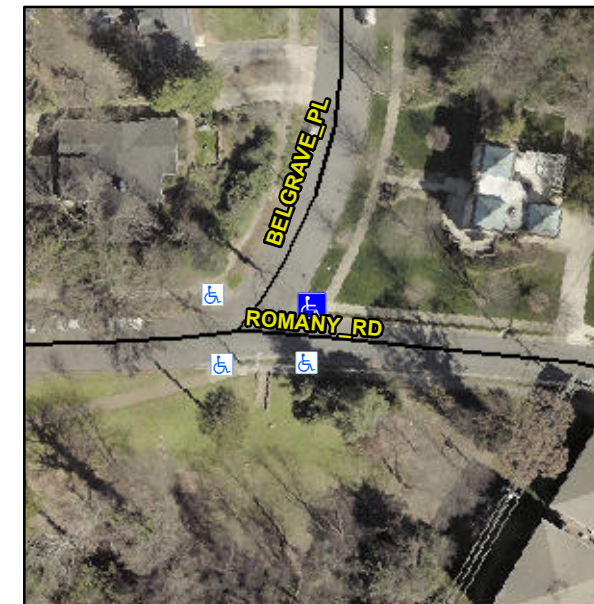
**Not Found, R304.5.3**

Compliance	Description	Data	Compliance	Description	Data
N/A	Ramp Length (in)	54.0	Yes	Ramp Slope (%)	7.2
Yes	Ramp Width (in)	50.0	No	Ramp XSlope (%)	9.2
N/A	Flare Type LT	N/A	N/A	Flare Type RT	N/A
N/A	Flare Slope LT (%)	N/A	N/A	Flare Slope RT (%)	N/A
N/A	Flare Traversable LT?	N/A	N/A	Flare Traversable RT?	N/A
N/A	Landing Length (in)	N/A	N/A	DWS Provided?	N/A
N/A	Landing Width (in)	N/A	N/A	DWS Contrast?	N/A
N/A	Landing Slope (%)	N/A	N/A	DWS Length (in)	N/A
N/A	Landing X Slope (%)	N/A	N/A	DWS Full Width?	N/A
N/A	Landing Curb? (Y/N)	N/A	N/A	DWS Offset (in)	N/A
N/A	Shared Landing?	N/A			
N/A	Gutter Ponding?	N/A	N/A	Gutter Slope (%)	N/A
N/A	Gutter Lip Ht (in)	N/A	N/A	Gutter X Slope (%)	N/A
N/A	Painted X Walk1?	No	N/A	Painted X Walk2?	No
	X Walk 1 Direction	To W		X Walk 2 Direction	To S
N/A	X Walk 1 Width (in)	N/A	N/A	X Walk 2 Width (in)	N/A
	X Walk 1 Slope (%)	6.2		X Walk 2 Slope (%)	0.9
	X Walk 1 X Slope (%)	2.6		X Walk 2 X Slope (%)	6.6

N/A	Ramp inside XWalk1?	N/A	N/A	Ramp inside XWalk2?	N/A
	Road Slope (%)	5.2	N/A	Clear Space?	N/A
	Road X Slope (%)	6.3	N/A	Clear Space to XWalk (in)	N/A
N/A	Any Obstructions?	N/A	N/A	Storm Grate/Utility Hazard?	N/A
	Obstruction Type			Storm Grate/Utility Type	
		N/A			N/A
			Yes	Surface Condition? (G/P)	Good

**Remove & Replace Curb Ramp With Two New Directional Ramps or Equivalent.**
