## Access Compliance Report Public Rights-of-Way (Curb Ramps)

Intersection ID: 31482	Main Street: COMMACK_DR			Cross Street: FLAGLER_LN				Location:	SW
ADA ID: 83242C47F365	Ramp Type: PerpDiag			Initial Pass/Fail: Fail Overall Compliance: No				o Severity Score:	8.75
Codes/Mitigation Info/Possible Solution				Field Measurements/Component Compliance					
ELACELER, LEA		Possible Solutions:		Compliance Description		Data	Data Compliance Description		Data
		Remove & Replace Curb Ramp W	/ith	N/A	Ramp Length (in)	49.5	Yes	Ramp Slope (%)	5.6
		Two New Directional Ramps or Equivalent.	-	No	Ramp Width (in)	40.5	Yes	Ramp XSlope (%)	1.4
				N/A	Flare Type LT	N/A	N/A	Flare Type RT	N/A
		đ		N/A	Flare Slope LT (%)	N/A	N/A	Flare Slope RT (%)	N/A
				N/A	Flare Traversable LT?	N/A	N/A	Flare Traversable RT?	N/A
				N/A	Landing Length (in)	N/A	N/A	DWS Provided?	N/A
		Surveyor Notes:		N/A	Landing Width (in)	N/A	N/A	DWS Contrast?	N/A
		N/A		N/A	Landing Slope (%)	N/A	N/A	DWS Length (in)	N/A

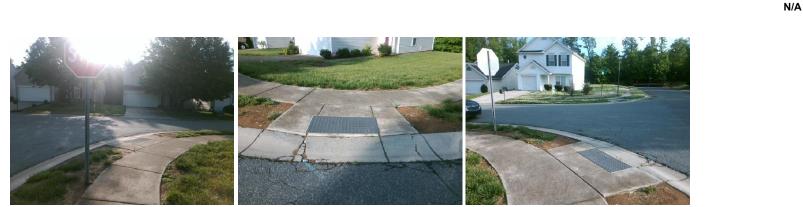
Yes Surface Condition? (G/P)

Good

Total Cost: \$ 32	200.00		Obstruction Type			Storm Grate/Utility Type	
						N/A			N/A
