# Access Compliance Report

## Public Rights-of-Way

| Intersection ID: 12605 | Main Street: KENSINGTON_DR | Cross Street: THE_PLAZA | Location: SW |
| ADA ID: 8329D82B7D97 | Ramp Type: Directional1 | Initial Pass/Fail: Fail | Overall Compliance: No |

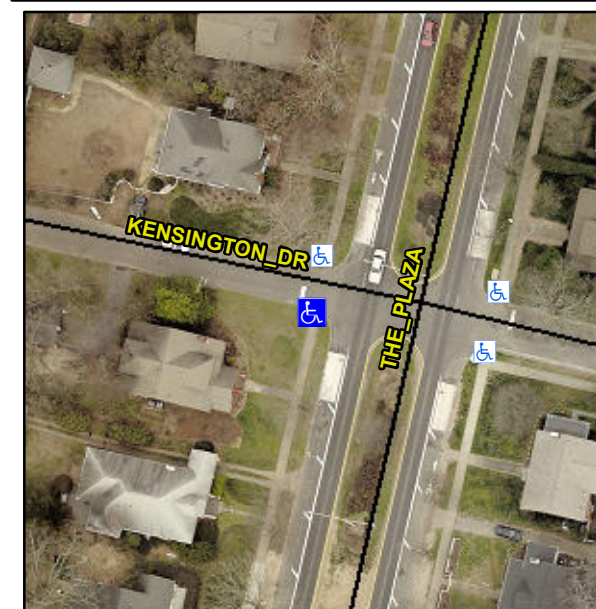
| Severity Score: 1.25 | | | |

**R304.5.3**

| Compliance | Description | Data | Compliance | Description | Data |
|---|---|---|---|---|---|
| No | Ramp XSlope (%) | 2.1 | | | |

**Remove & Replace Entire Ramp.**
