Intersection ID: 12957	Main Street: HAMORTON_PL	Cross Street: PECAN_AV	Location:	NW
ADA ID: 8336BD1DC487	Ramp Type: PerpDiag	Initial Pass/Fail: Fail	Overall Compliance: No	Severity Score: 8.75

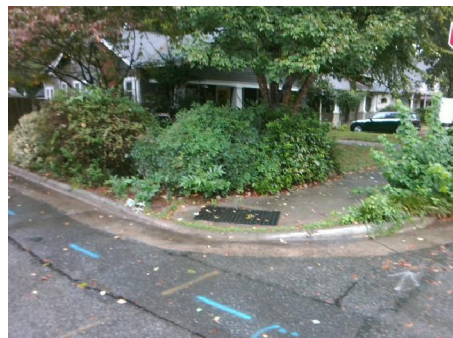
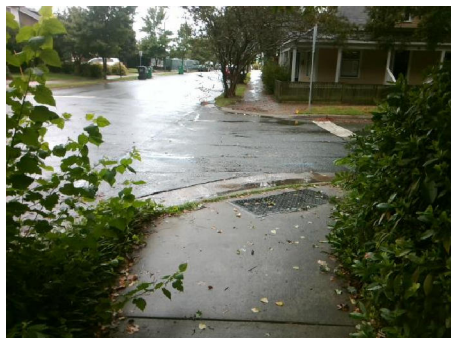
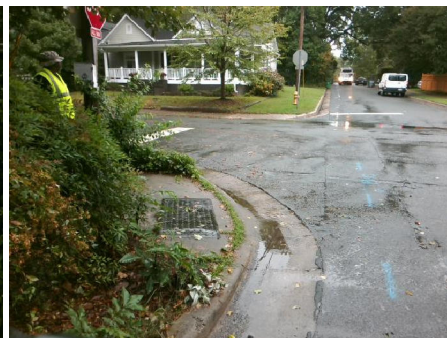
Not Found, R304.5.1

Compliance	Description	Data	Compliance	Description	Data
N/A	Ramp Length (in)	41.0	Yes	Ramp Slope (%)	5.9
No	Ramp Width (in)	47.0	Yes	Ramp XSlope (%)	0.7
N/A	Flare Type LT	N/A	N/A	Flare Type RT	N/A
N/A	Flare Slope LT (%)	N/A	N/A	Flare Slope RT (%)	N/A
N/A	Flare Traversable LT?	N/A	N/A	Flare Traversable RT?	N/A
N/A	Landing Length (in)	N/A	N/A	DWS Provided?	N/A
N/A	Landing Width (in)	N/A	N/A	DWS Contrast?	N/A
N/A	Landing Slope (%)	N/A	N/A	DWS Length (in)	N/A
N/A	Landing X Slope (%)	N/A	N/A	DWS Full Width?	N/A
N/A	Landing Curb? (Y/N)	N/A	N/A	DWS Offset (in)	N/A
N/A	Shared Landing?	N/A			
N/A	Gutter Ponding?	N/A	N/A	Gutter Slope (%)	N/A
N/A	Gutter Lip Ht (in)	N/A	N/A	Gutter X Slope (%)	N/A
N/A	Painted X Walk1?	No	N/A	Painted X Walk2?	No
	X Walk 1 Direction	To S		X Walk 2 Direction	To E
N/A	X Walk 1 Width (in)	N/A	N/A	X Walk 2 Width (in)	N/A
	X Walk 1 Slope (%)	4.4		X Walk 2 Slope (%)	4.4
	X Walk 1 X Slope (%)	1.9		X Walk 2 X Slope (%)	3.9

N/A	Ramp inside XWalk1?	N/A	N/A	Ramp inside XWalk2?	N/A
	Road Slope (%)	0.3	N/A	Clear Space?	N/A
	Road X Slope (%)	3.8	N/A	Clear Space to XWalk (in)	N/A
N/A	Any Obstructions?	N/A	N/A	Storm Grate/Utility Hazard?	N/A
	Obstruction Type			Storm Grate/Utility Type	
		N/A			N/A
			Yes	Surface Condition? (G/P)	Good

Remove & Replace Curb Ramp With Two New Directional Ramps or Equivalent.
