Access Compliance Report

Public Rights-of-Way

(Curb Ramps)

| Intersection ID: 15160 | Main Street: GRIFFITH_ST | Cross Street: S_TRYON_ST | Location: | N |

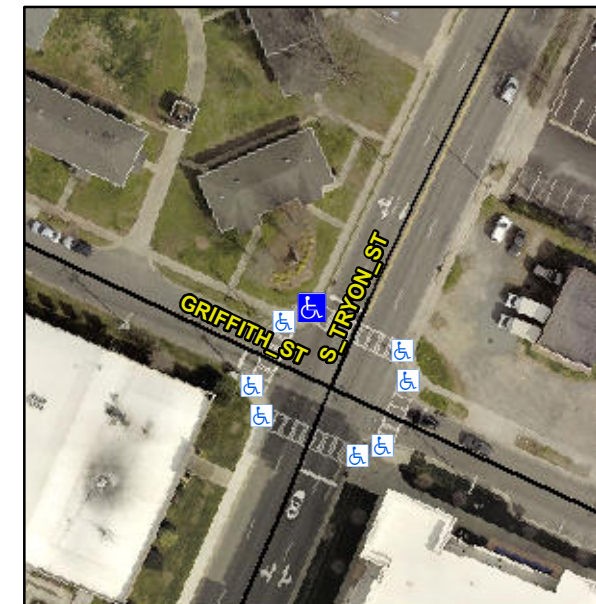
| ADA ID: 8347633205E5 | Ramp Type: Perp | Initial Pass/Fail: Fail | Overall Compliance: No | Severity Score: 22.5 |

Not Found, R304.5.1, R304.2.2, R304.5.3

| Compliance | Description | Data | Compliance | Description | Data |
|---|---|---|---|---|---|
| N/A | Ramp Length (in) | 80.0 | No | Ramp Slope (%) | 9.0 |
| No | Ramp Width (in) | 46.0 | No | Ramp XSlope (%) | 2.1 |

Possible Solutions:

Remove & Replace Entire Ramp.
