# Access Compliance Report

## Public Rights-of-Way

### (Curb Ramps)

Intersection ID: 20840	Main Street: SARDIS_LN	Cross Street: SARDIS_RD	Location: NW
ADA ID: 83520A4BFDCE	Ramp Type: PerpDiag	Initial Pass/Fail: Fail	Overall Compliance: No
		Severity Score: 35

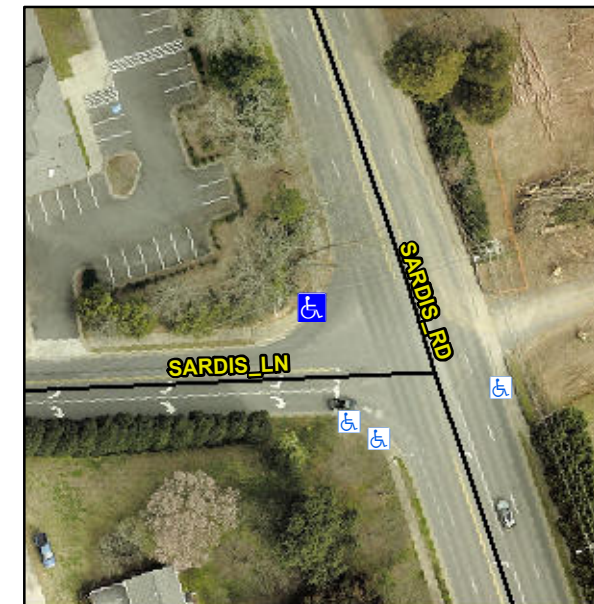
Compliance	Description	Data	Compliance	Description	Data
N/A	Ramp Length (in)	60.5	No	Ramp Slope (%)	12.5
No	Ramp Width (in)	44.0	No	Ramp XSlope (%)	2.9
N/A	Flare Type LT	N/A	N/A	Flare Type RT	N/A
N/A	Flare Slope LT (%)	N/A	N/A	Flare Slope RT (%)	N/A
N/A	Flare Traversable LT?	N/A	N/A	Flare Traversable RT?	N/A
N/A	Landing Length (in)	N/A	N/A	DWS Provided?	N/A
N/A	Landing Width (in)	N/A	N/A	DWS Contrast?	N/A
N/A	Landing Slope (%)	N/A	N/A	DWS Length (in)	N/A
N/A	Landing X Slope (%)	N/A	N/A	DWS Full Width?	N/A
N/A	Landing Curb? (Y/N)	N/A	N/A	DWS Offset (in)	N/A
N/A	Shared Landing?	N/A			
N/A	Gutter Ponding?	N/A	N/A	Gutter Slope (%)	N/A
N/A	Gutter Lip Ht (in)	N/A	N/A	Gutter X Slope (%)	N/A
N/A	Painted X Walk1?	No	N/A	Painted X Walk2?	No
	X Walk 1 Direction	To S		X Walk 2 Direction	To E
N/A	X Walk 1 Width (in)	N/A	N/A	X Walk 2 Width (in)	N/A
	X Walk 1 Slope (%)	2.8		X Walk 2 Slope (%)	4.2
	X Walk 1 X Slope (%)	3.5		X Walk 2 X Slope (%)	0.6

N/A	Ramp inside XWalk1?	N/A	N/A	Ramp inside XWalk2?	N/A
	Road Slope (%)	2.6	N/A	Clear Space?	N/A
	Road X Slope (%)	1.9	N/A	Clear Space to XWalk (in)	N/A
N/A	Any Obstructions?	N/A	N/A	Storm Grate/Utility Hazard?	N/A
	Obstruction Type			Storm Grate/Utility Type	
		N/A			N/A
			Yes	Surface Condition? (G/P)	Good

**Remove & Replace Curb Ramp With Two New Directional Ramps or Equivalent.**

**R304.5.1, R304.2.2, R304.5.3**
