Access Compliance Report

Public Rights-of-Way

(Curb Ramps)

Intersection ID: 23899	Main Street: CARTGATE_LN	Cross Street: STEPHENDALE_DR	Location: NE
ADA ID: 83615BDF206C	Ramp Type: PerpDiag	Initial Pass/Fail: Fail	Overall Compliance: No
Severity Score: 13.75			
Codes/Mitigation Info/Possible Solution		Field Measurements/Component Compliance

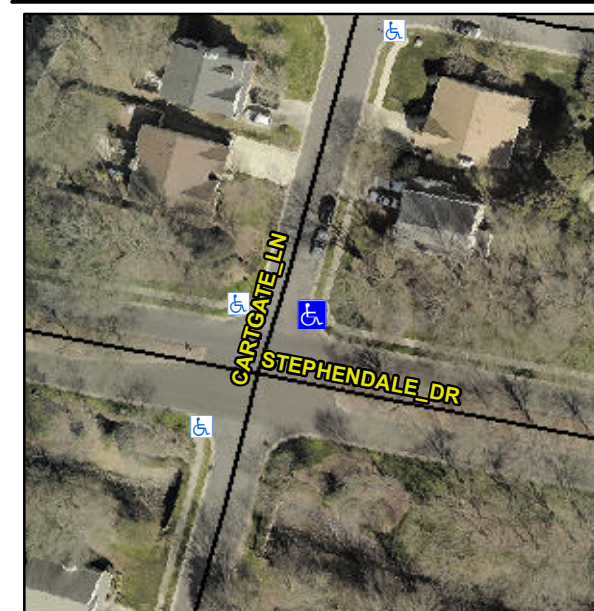
R304.2.2, R304.5.3

Compliance	Description	Data	Compliance	Description	Data
N/A	Ramp Length (in)	95.0	No	Ramp Slope (%)	9.5
Yes	Ramp Width (in)	48.0	No	Ramp XSlope (%)	3.9
N/A	Flare Type LT	N/A	N/A	Flare Type RT	N/A
N/A	Flare Slope LT (%)	N/A	N/A	Flare Slope RT (%)	N/A
N/A	Flare Traversable LT?	N/A	N/A	Flare Traversable RT?	N/A
N/A	Landing Length (in)	N/A	N/A	DWS Provided?	N/A
N/A	Landing Width (in)	N/A	N/A	DWS Contrast?	N/A
N/A	Landing Slope (%)	N/A	N/A	DWS Length (in)	N/A
N/A	Landing X Slope (%)	N/A	N/A	DWS Full Width?	N/A
N/A	Landing Curb? (Y/N)	N/A	N/A	DWS Offset (in)	N/A
N/A	Shared Landing?	N/A			
N/A	Gutter Ponding?	N/A	N/A	Gutter Slope (%)	N/A
N/A	Gutter Lip Ht (in)	N/A	N/A	Gutter X Slope (%)	N/A
N/A	Painted X Walk1?	No	N/A	Painted X Walk2?	No
	X Walk 1 Direction	To NW		X Walk 2 Direction	To SW
N/A	X Walk 1 Width (in)	N/A	N/A	X Walk 2 Width (in)	N/A
	X Walk 1 Slope (%)	0.9		X Walk 2 Slope (%)	1.4
	X Walk 1 X Slope (%)	3.6		X Walk 2 X Slope (%)	1.8

N/A	Ramp inside XWalk1?	N/A	N/A	Ramp inside XWalk2?	N/A
	Road Slope (%)	1.5	N/A	Clear Space?	N/A
	Road X Slope (%)	4.6	N/A	Clear Space to XWalk (in)	N/A
N/A	Any Obstructions?	N/A	N/A	Storm Grate/Utility Hazard?	N/A
	Obstruction Type			Storm Grate/Utility Type	
		N/A			N/A
		Yes		Surface Condition? (G/P)	Good

Possible Solutions:

Remove & Replace Curb Ramp With Two New Directional Ramps or Equivalent.
