# Access Compliance Report

## Public Rights-of-Way

### (Curb Ramps)

| Intersection ID: 2606 | Main Street: CROWNVISTA_DR | Cross Street: FAIRVISTA_DR | Location: S |

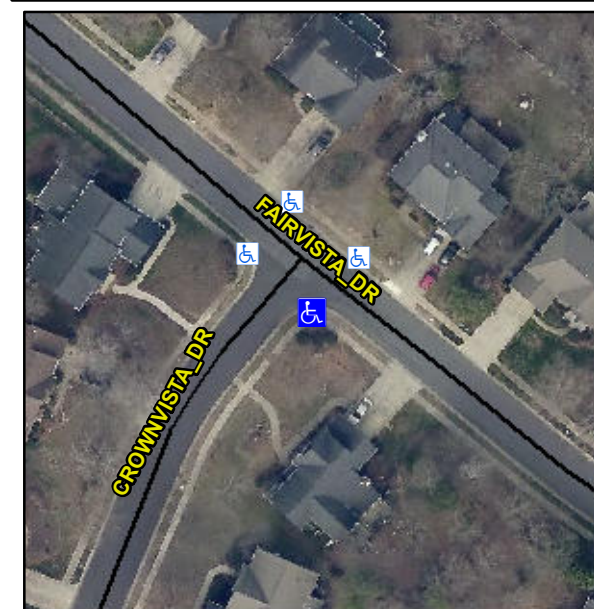
**Not Found, R304.5.1, R304.2.2**

| Compliance | Description | Data | Compliance | Description | Data |
|---|---|---|---|---|---|
| N/A | Ramp Length (in) | 49.0 | No | Ramp Slope (%) | 10.4 |
| No | Ramp Width (in) | 41.0 | Yes | Ramp XSlope (%) | 1.4 |

**Remove & Replace Curb Ramp With Two New Directional Ramps or Equivalent.**
