# Access Compliance Report

## Public Rights-of-Way

### (Curb Ramps)

| Intersection ID: 8378 | Main Street: LASALLE_ST | Cross Street: QUENTIN_ST | Location: | E |

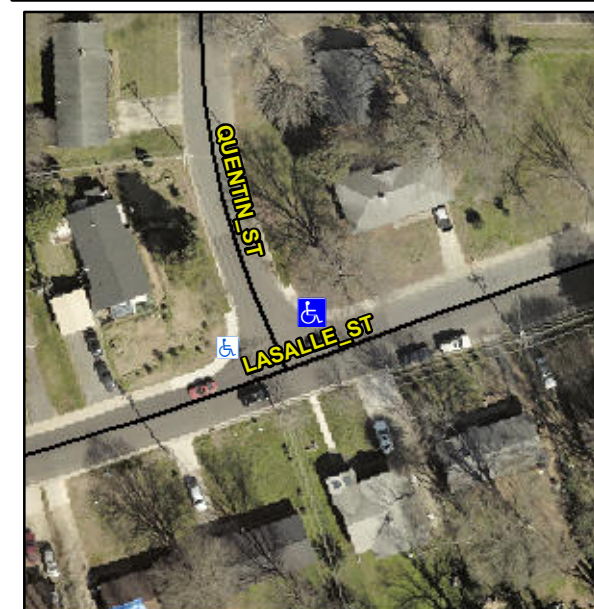
| ADA ID: 83797B6D5F90 | Ramp Type: Perp | Initial Pass/Fail: Fail | Overall Compliance: No | Severity Score: 12.5 |

**Not Found, R304.2.2**

| Compliance | Description | Data | Compliance | Description | Data |
|---|---|---|---|---|---|
| N/A | Ramp Length (in) | 36.0 | No | Ramp Slope (%) | 9.6 |
| Yes | Ramp Width (in) | 50.0 | Yes | Ramp XSlope (%) | 1.4 |

**Remove & Replace Entire Ramp.**

Total Cost: \$ 1850.00

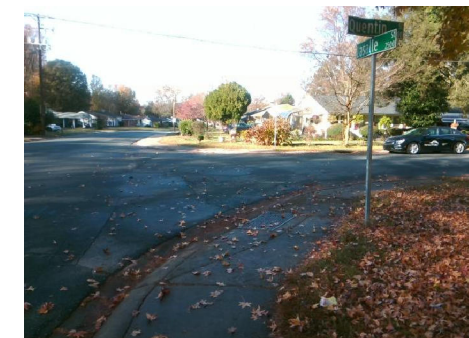
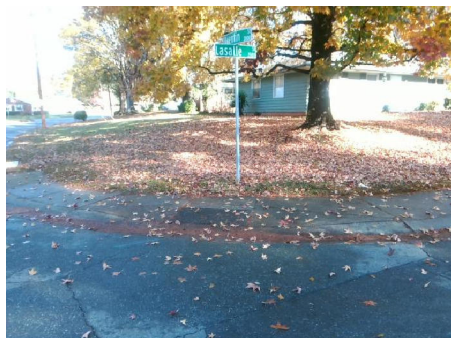
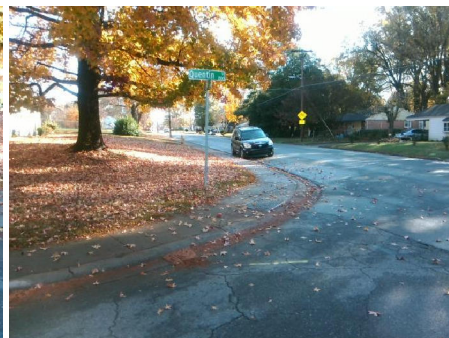
Street 1 Name **QUENTIN ST**  
 Stop Condition-Street 2 **StopSign**  
 Street 2 Name **N/A**  
 Stop Condition-Street 1 **N/A**
