Access Compliance Report

Public Rights-of-Way (Curb Ramps)

Intersection ID: 43374	Main Street: COOPER'S RIDGE LN	Cross Street: BERNBROOKE_SHADOW LN	Location: S
ADA ID: 83838E29C1C2	Ramp Type: BlendTrans1	Initial Pass/Fail: Fail	Overall Compliance: No
Severity Score: 21.25			
Codes/Mitigation Info/Possible Solution		Field Measurements/Component Compliance

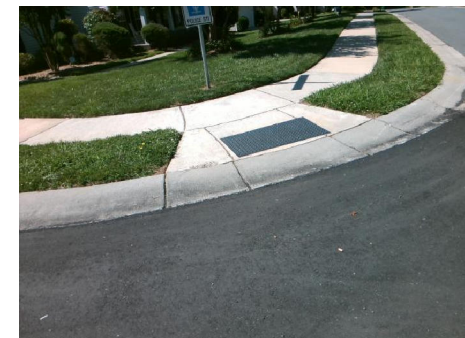
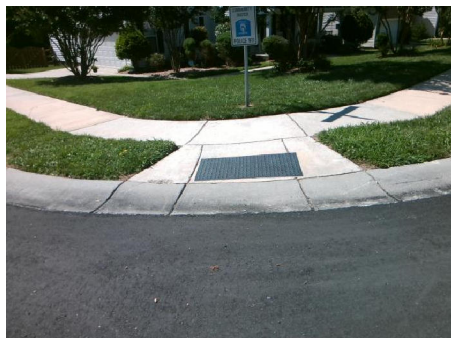
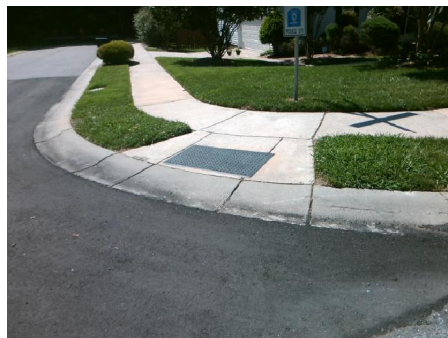
Not Found, R304.5.1, R304.5.3

Compliance	Description	Data	Compliance	Description	Data
N/A	Ramp Length (in)	48.0	Yes	BlendTrans Slope (%)	2.6
No	Ramp Width (in)	43.0	No	BlendTrans XSlope (%)	5.9
N/A	Flare Type LT	N/A	N/A	Flare Type RT	N/A
N/A	Flare Slope LT (%)	N/A	N/A	Flare Slope RT (%)	N/A
N/A	Flare Traversable LT?	N/A	N/A	Flare Traversable RT?	N/A
N/A	Landing Length (in)	N/A	N/A	DWS Provided?	N/A
N/A	Landing Width (in)	N/A	N/A	DWS Contrast?	N/A
N/A	Landing Slope (%)	N/A	N/A	DWS Length (in)	N/A
N/A	Landing X Slope (%)	N/A	N/A	DWS Full Width?	N/A
N/A	Landing Curb? (Y/N)	N/A	N/A	DWS Offset (in)	N/A
N/A	Shared Landing?	N/A			
N/A	Gutter Ponding?	N/A	N/A	Gutter Slope (%)	N/A
N/A	Gutter Lip Ht (in)	N/A	N/A	Gutter X Slope (%)	N/A
N/A	Painted X Walk1?	No	N/A	Painted X Walk2?	No
	X Walk 1 Direction	To NE		X Walk 2 Direction	To NW
	X Walk 1 Width (in)	N/A		X Walk 2 Width (in)	N/A
	X Walk 1 Slope (%)	0.6		X Walk 2 Slope (%)	3.5
	X Walk 1 X Slope (%)	4.9		X Walk 2 X Slope (%)	1.2

N/A	Ramp inside XWalk1?	N/A	N/A	Ramp inside XWalk2?	N/A
	Road Slope (%)	4.3		Clear Space?	N/A
	Road X Slope (%)	2.4	N/A	Clear Space to XWalk (in)	N/A
N/A	Any Obstructions?	N/A	N/A	Storm Grate/Utility Hazard?	N/A
	Obstruction Type			Storm Grate/Utility Type	
		N/A			N/A
			Yes	Surface Condition? (G/P)	Good
			No	Curb Slope (%)	10.0

Remove & Replace Curb Ramp With Two New Directional Ramps or Equivalent.

Total Cost: \$ 3200.00
