Access Compliance Report Public Rights-of-Way (Curb Ramps)

Intersection ID: 10040845	Main Street: WAKEFIELD_DR		Cross	Street:	N/A	Location:	E		
ADA ID: 83956E5D51AD	Ramp Type: PerpDiag			nitial Pass/Fail: Fail Overall Compliance: No				o Severity Score:	25
Codes/Mitigation Info/Possible Solution				Field Measurements/Component Compliance					
		Possible Solutions:		Compliance Description Data Co			Comp	Compliance Description Data	
		Remove & Replace Curb Ramp \	With	N/A	Ramp Length (in)	60.0	Yes	Ramp Slope (%)	5.5
		Two New Directional Ramps or Equivalent.		Yes	Ramp Width (in)	48.0	No	Ramp XSlope (%)	9.8
				N/A	Flare Type LT	N/A	N/A	Flare Type RT	N/A
				N/A	Flare Slope LT (%)	N/A	N/A	Flare Slope RT (%)	N/A
				N/A	Flare Traversable LT?	N/A	N/A	Flare Traversable RT?	N/A
				N/A	Landing Length (in)	N/A	N/A	DWS Provided?	N/A
MAKEFIELD		Surveyor Notes:		N/A	Landing Width (in)	N/A	N/A	DWS Contrast?	N/A
		N/A		N/A	Landing Slope (%)	N/A	N/A	DWS Length (in)	N/A
A TAL				N/A	Landing X Slope (%)	N/A	N/A	DWS Full Width?	N/A

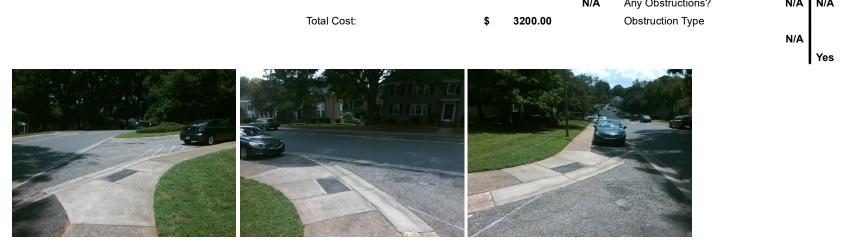
N/A	Landing Curb? (Y/N)	N/A	N/A	DWS Offset (in)	N/A
A STREET, AND A ST	Jane -			N/A	Shared Landing?	N/A			
		PROW/ADA:		N/A	Gutter Ponding?	N/A	N/A	Gutter Slope (%)	N/A
and shake there		Not Found, R304.5.3		N/A	Gutter Lip Ht (in)	N/A	N/A	Gutter X Slope (%)	N/A
and the second second				N/A	Painted X Walk1?	No	N/A	Painted X Walk2?	No
All and the second s	Eller - Take				X Walk 1 Direction	To W		X Walk 2 Direction	To S
				N/A	X Walk 1 Width (in)	N/A	N/A	X Walk 2 Width (in)	N/A
Street 1 Name	ENTRANCE				X Walk 1 Slope (%)	5.5		X Walk 2 Slope (%)	9.1
Stop Condition-Street 2	None				X Walk 1 X Slope (%)	5.2		X Walk 2 X Slope (%)	7.1
Street 2 Name	WAKEFIELD DR			N/A	Ramp inside XWalk1?	N/A	N/A	Ramp inside XWalk2?	N/A
Stop Condition-Street 1	None				Road Slope (%)	7.6	N/A	Clear Space?	N/A
					Road X Slope (%)	2.3	N/A	Clear Space to XWalk (in)	N/A
				N/A	Any Obstructions?	N/A	N/A	Storm Grate/Utility Hazard?	N/A

Total Cost: \$	3200.00		Obstruction Type			Storm Grate/Utility Type	
						N/A			N/A
1							•
