Access Compliance Report Public Rights-of-Way (Curb Ramps)

Intersection ID: 6207Main Street: COTTONWOOD_PARK_DRCross Street: VALLEYDALE_RDLocation:SADA ID: 83AC35DB7840Ramp Type: PerpDiagInitial Pass/Fail: FailOverall Compliance: NoSeverity Score:52.5

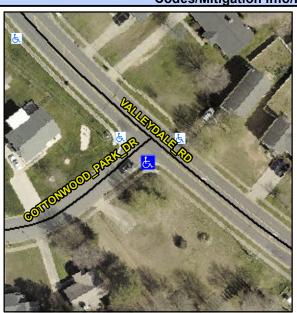
Not Found, R304.2.2, R304.5.3, R302.7

Field Measurements/Component Compilance					
Compliance Description		Data	Compliance Description		Data
N/A	Ramp Length (in)	48.0	No	Ramp Slope (%)	12.3
Yes	Ramp Width (in)	48.0	No	Ramp XSlope (%)	5.5
N/A	Flare Type LT	N/A	N/A	Flare Type RT	N/A
N/A	Flare Slope LT (%)	N/A	N/A	Flare Slope RT (%)	N/A
N/A	Flare Traversable LT?	N/A	N/A	Flare Traversable RT?	N/A
N/A	Landing Length (in)	N/A	N/A	DWS Provided?	N/A
N/A	Landing Width (in)	N/A	N/A	DWS Contrast?	N/A
N/A	Landing Slope (%)	N/A	N/A	DWS Length (in)	N/A
N/A	Landing X Slope (%)	N/A	N/A	DWS Full Width?	N/A
N/A	Landing Curb? (Y/N)	N/A	N/A	DWS Offset (in)	N/A
N/A	Shared Landing?	N/A			
N/A	Gutter Ponding?	N/A	N/A	Gutter Slope (%)	N/A
N/A	Gutter Lip Ht (in)	N/A	N/A	Gutter X Slope (%)	N/A
N/A	Painted X Walk1?	No	N/A	Painted X Walk2?	No
	X Walk 1 Direction	To NE		X Walk 2 Direction	To NW
N/A	X Walk 1 Width (in)	N/A	N/A	X Walk 2 Width (in)	N/A
	X Walk 1 Slope (%)	0.7		X Walk 2 Slope (%)	2.1

X Walk 1 X Slope (%)	3.1		X Walk 2 X Slope (%)	1.9
N/A	Ramp inside XWalk1?	N/A	N/A	Ramp inside XWalk2?	N/A
	Road Slope (%)	3.9	N/A	Clear Space?	N/A
	Road X Slope (%)	0.3	N/A	Clear Space to XWalk (in)	N/A
N/A	Any Obstructions?	N/A	N/A	Storm Grate/Utility Hazard?	N/A
	Obstruction Type		Į.	Storm Grate/Utility Type	
		N/A			N/A
			No	Surface Condition? (G/P)	Poor

Remove & Replace Curb Ramp With Two New Directional Ramps or Equivalent.
