Access Compliance Report

Public Rights-of-Way

(Curb Ramps)

Intersection ID: 24751	Main Street: CINNAMON_FIELD_RD	Cross Street: WILD_HEATHER_CT	Location: NW
ADA ID: 83BC11A65BCD	Ramp Type: Perp	Initial Pass/Fail: Fail	Overall Compliance: No
Severity Score: 30			
Codes/Mitigation Info/Possible Solution		Field Measurements/Component Compliance

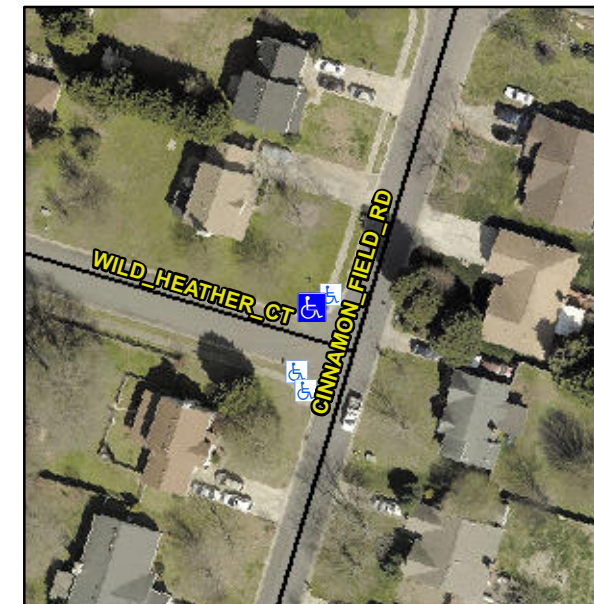
Compliance	Description	Data	Compliance	Description	Data
N/A	Ramp Length (in)	92.0	No	Ramp Slope (%)	8.9
No	Ramp Width (in)	32.0	Yes	Ramp XSlope (%)	1.5
N/A	Flare Type LT	N/A	N/A	Flare Type RT	N/A
N/A	Flare Slope LT (%)	N/A	N/A	Flare Slope RT (%)	N/A
N/A	Flare Traversable LT?	N/A	N/A	Flare Traversable RT?	N/A
N/A	Landing Length (in)	N/A	N/A	DWS Provided?	N/A
N/A	Landing Width (in)	N/A	N/A	DWS Contrast?	N/A
N/A	Landing Slope (%)	N/A	N/A	DWS Length (in)	N/A
N/A	Landing X Slope (%)	N/A	N/A	DWS Full Width?	N/A
N/A	Landing Curb? (Y/N)	N/A	N/A	DWS Offset (in)	N/A
N/A	Shared Landing?	N/A			
N/A	Gutter Ponding?	N/A	N/A	Gutter Slope (%)	N/A
N/A	Gutter Lip Ht (in)	N/A	N/A	Gutter X Slope (%)	N/A
N/A	Painted X Walk1?	No	N/A	Painted X Walk2?	N/A
	X Walk 1 Direction	To SW		X Walk 2 Direction	N/A
N/A	X Walk 1 Width (in)	N/A	N/A	X Walk 2 Width (in)	N/A
	X Walk 1 Slope (%)	2.2		X Walk 2 Slope (%)	N/A
	X Walk 1 X Slope (%)	0.3		X Walk 2 X Slope (%)	N/A

N/A	Ramp inside XWalk1?	N/A	N/A	Ramp inside XWalk2?	N/A
	Road Slope (%)	N/A	N/A	Clear Space?	N/A
	Road X Slope (%)	N/A	N/A	Clear Space to XWalk (in)	N/A
N/A	Any Obstructions?	N/A	N/A	Storm Grate/Utility Hazard?	N/A
	Obstruction Type			Storm Grate/Utility Type	
		N/A			N/A
			Yes	Surface Condition? (G/P)	Good

Remove & Replace Entire Ramp.

R304.5.1, R304.2.2
