Access Compliance Report

Public Rights-of-Way

(Curb Ramps)

Intersection ID: 16396	Main Street: BEAL_ST	Cross Street: N_WENDOVER_RD	Location: W
ADA ID: 83D611C68E72	Ramp Type: PerpDiag	Initial Pass/Fail: Fail	Overall Compliance: No
Severity Score: 13.75			
Codes/Mitigation Info/Possible Solution		Field Measurements/Component Compliance

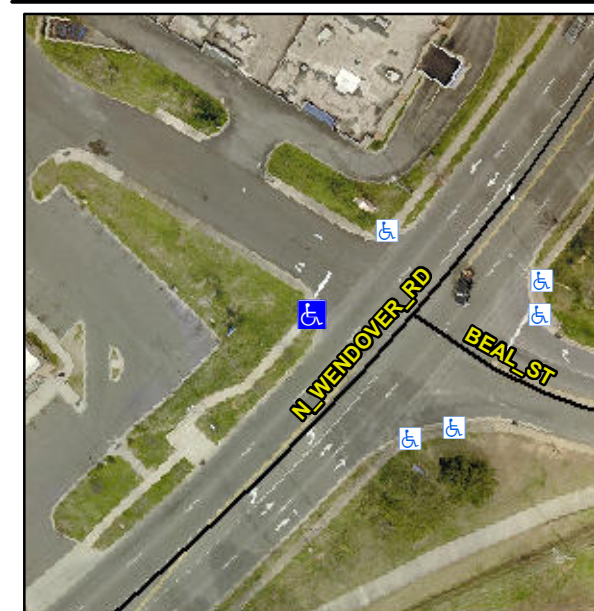
R304.2.2, R304.5.3

Compliance	Description	Data	Compliance	Description	Data
N/A	Ramp Length (in)	57.0	No	Ramp Slope (%)	8.7
Yes	Ramp Width (in)	59.0	No	Ramp XSlope (%)	2.6
N/A	Flare Type LT	N/A	N/A	Flare Type RT	N/A
N/A	Flare Slope LT (%)	N/A	N/A	Flare Slope RT (%)	N/A
N/A	Flare Traversable LT?	N/A	N/A	Flare Traversable RT?	N/A
N/A	Landing Length (in)	N/A	N/A	DWS Provided?	N/A
N/A	Landing Width (in)	N/A	N/A	DWS Contrast?	N/A
N/A	Landing Slope (%)	N/A	N/A	DWS Length (in)	N/A
N/A	Landing X Slope (%)	N/A	N/A	DWS Full Width?	N/A
N/A	Landing Curb? (Y/N)	N/A	N/A	DWS Offset (in)	N/A
N/A	Shared Landing?	N/A			
N/A	Gutter Ponding?	N/A	N/A	Gutter Slope (%)	N/A
N/A	Gutter Lip Ht (in)	N/A	N/A	Gutter X Slope (%)	N/A
N/A	Painted X Walk1?	No	N/A	Painted X Walk2?	No
	X Walk 1 Direction	To SE		X Walk 2 Direction	To NE
N/A	X Walk 1 Width (in)	N/A	N/A	X Walk 2 Width (in)	N/A
	X Walk 1 Slope (%)	2.3		X Walk 2 Slope (%)	3.9
	X Walk 1 X Slope (%)	0.9		X Walk 2 X Slope (%)	0.0

N/A	Ramp inside XWalk1?	N/A	N/A	Ramp inside XWalk2?	N/A
	Road Slope (%)	1.3	N/A	Clear Space?	N/A
	Road X Slope (%)	1.4	N/A	Clear Space to XWalk (in)	N/A
N/A	Any Obstructions?	N/A	N/A	Storm Grate/Utility Hazard?	N/A
	Obstruction Type			Storm Grate/Utility Type	
		N/A			N/A
		Yes		Surface Condition? (G/P)	Good

Remove & Replace Curb Ramp With Two New Directional Ramps or Equivalent.

Total Cost: \$ 3200.00
