## Access Compliance Report Public Rights-of-Way (Curb Ramps)

Intersection ID: 29232 Main Street: ROCKWELL\_BV Cross Street: ROCKWELL\_BV\_WEST Location: W

ADA ID: 83D82D58EFA1 Ramp Type: Para Initial Pass/Fail: Fail Overall Compliance: No Severity Score: 33.75

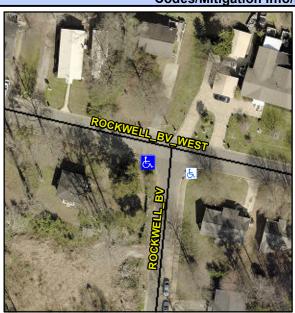
CURB GAP 1.0

Field Measurements/Component Compliance					
Compliance Description		Data	Compliance Description		Data
N/A	Ramp Length LT (in)	59.0	N/A	Ramp Length RT (in)	37.0
No	Ramp Width LT (in)	36.0	Yes	Ramp Width RT (in)	64.0
No	Ramp Slope LT (%)	15.6	Yes	Ramp Slope RT (%)	5.2
Yes	Ramp XSlope LT (%)	0.5	Yes	Ramp XSlope RT (%)	1.7
N/A	Landing Length (in)	N/A	N/A	DWS Provided?	N/A
N/A	Landing Width (in)	N/A	N/A	DWS Contrast?	N/A
N/A	Landing Slope (%)	N/A	N/A	DWS Length (in)	N/A
N/A	Landing X Slope (%)	N/A	N/A	DWS Full Width?	N/A
N/A	Landing Curb? (Y/N)	N/A	N/A	DWS Offset (in)	N/A
N/A	Shared Landing?	N/A			
N/A	Gutter Ponding?	N/A	N/A	Gutter Slope (%)	N/A
N/A	Gutter Lip Ht (in)	N/A	N/A	Gutter X Slope (%)	N/A
N/A	Painted X Walk1?	No	N/A	Painted X Walk2?	N/A
	X Walk 1 Direction	To E		X Walk 2 Direction	N/A
N/A	X Walk 1 Width (in)	N/A	N/A	X Walk 2 Width (in)	N/A
	X Walk 1 Slope (%)	9.8		X Walk 2 Slope (%)	N/A
	X Walk 1 X Slope (%)	3.5		X Walk 2 X Slope (%)	N/A

N/A	Ramp inside XWalk1?	N/A	N/A	Ramp inside XWalk2?	N/A
	Road Slope (%)	N/A	N/A	Clear Space?	N/A
	Road X Slope (%)	N/A	N/A	Clear Space to XWalk (in)	N/A
N/A	Any Obstructions?	N/A	N/A	Storm Grate/Utility Hazard?	N/A
	Obstruction Type			Storm Grate/Utility Type	
		N/A			N/A
			Yes	Surface Condition? (G/P)	Good
			N/A	Curb Slope (%)	10.5

Remove & Replace Entire Ramp.
