Access Compliance Report

Public Rights-of-Way

(Curb Ramps)

Intersection ID: 14857	Main Street: ATHERTON_ST	Cross Street: SOUTH_BV	Location: S
ADA ID: 83DA5317C2D8	Ramp Type: Perp	Initial Pass/Fail: Fail	Overall Compliance: No
Severity Score: 35			
Codes/Mitigation Info/Possible Solution		Field Measurements/Component Compliance

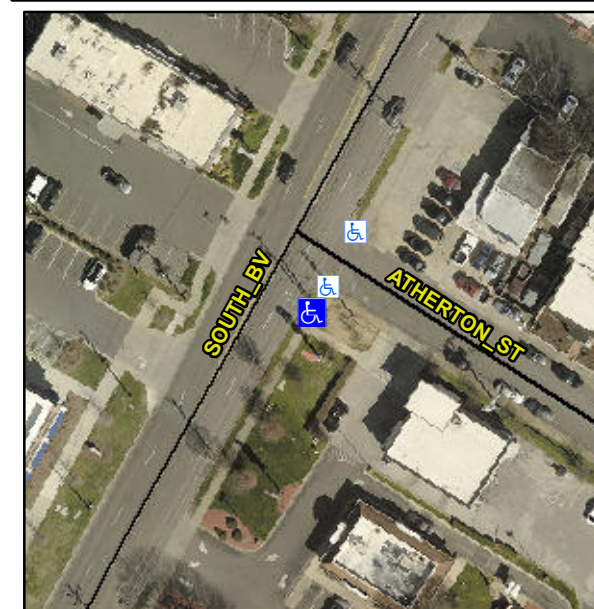
Not Found, R304.5.1, R304.2.2

Compliance	Description	Data	Compliance	Description	Data
N/A	Ramp Length (in)	51.0	No	Ramp Slope (%)	14.1
No	Ramp Width (in)	37.0	Yes	Ramp XSlope (%)	3.7
N/A	Flare Type LT	N/A	N/A	Flare Type RT	N/A
N/A	Flare Slope LT (%)	N/A	N/A	Flare Slope RT (%)	N/A
N/A	Flare Traversable LT?	N/A	N/A	Flare Traversable RT?	N/A
N/A	Landing Length (in)	N/A	N/A	DWS Provided?	N/A
N/A	Landing Width (in)	N/A	N/A	DWS Contrast?	N/A
N/A	Landing Slope (%)	N/A	N/A	DWS Length (in)	N/A
N/A	Landing X Slope (%)	N/A	N/A	DWS Full Width?	N/A
N/A	Landing Curb? (Y/N)	N/A	N/A	DWS Offset (in)	N/A
N/A	Shared Landing?	N/A			
N/A	Gutter Ponding?	N/A	N/A	Gutter Slope (%)	N/A
N/A	Gutter Lip Ht (in)	N/A	N/A	Gutter X Slope (%)	N/A
N/A	Painted X Walk1?	No	N/A	Painted X Walk2?	N/A
	X Walk 1 Direction	To NW		X Walk 2 Direction	N/A
N/A	X Walk 1 Width (in)	N/A	N/A	X Walk 2 Width (in)	N/A
	X Walk 1 Slope (%)	4.1		X Walk 2 Slope (%)	N/A
	X Walk 1 X Slope (%)	3.9		X Walk 2 X Slope (%)	N/A

N/A	Ramp inside XWalk1?	N/A	N/A	Ramp inside XWalk2?	N/A
	Road Slope (%)	N/A	N/A	Clear Space?	N/A
	Road X Slope (%)	N/A	N/A	Clear Space to XWalk (in)	N/A
N/A	Any Obstructions?	N/A	N/A	Storm Grate/Utility Hazard?	N/A
	Obstruction Type			Storm Grate/Utility Type	
		N/A			N/A
			Yes	Surface Condition? (G/P)	Good

Remove & Replace Entire Ramp.
