Access Compliance Report

Public Rights-of-Way

(Curb Ramps)

Intersection ID: 16114	Main Street: HAMPTON_AV	Cross Street: OXFORD_PL	Location: SE
ADA ID: 83EDCA065379	Ramp Type: PerpDiag	Initial Pass/Fail: Fail	Overall Compliance: No
Codes/Mitigation Info/Possible Solution		Field Measurements/Component Compliance

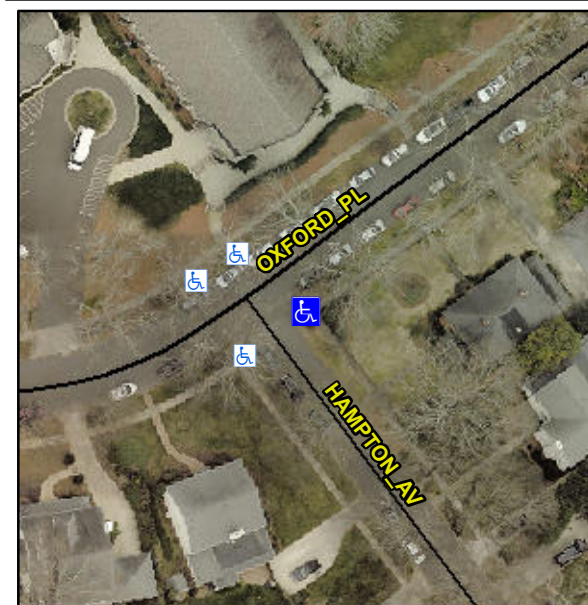
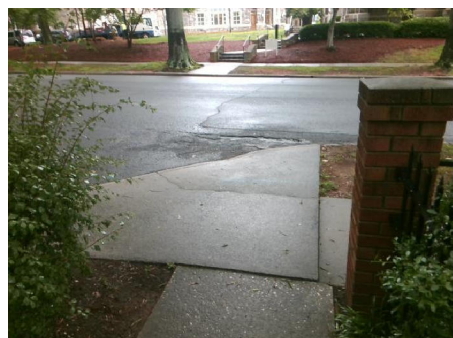
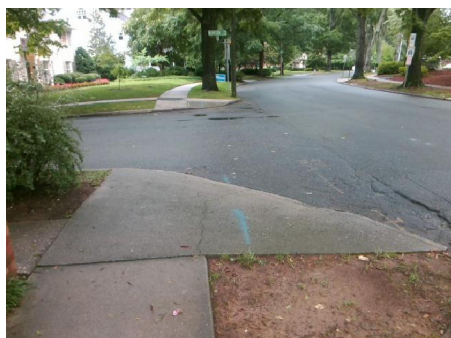
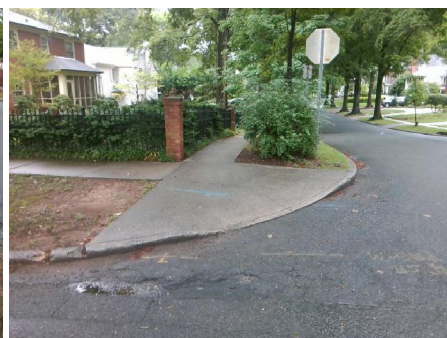
Not Found, R304.2.2, R304.5.3

Compliance	Description	Data	Compliance	Description	Data
N/A	Ramp Length (in)	64.0	No	Ramp Slope (%)	9.9
Yes	Ramp Width (in)	48.0	No	Ramp XSlope (%)	2.9
N/A	Flare Type LT	N/A	N/A	Flare Type RT	N/A
N/A	Flare Slope LT (%)	N/A	N/A	Flare Slope RT (%)	N/A
N/A	Flare Traversable LT?	N/A	N/A	Flare Traversable RT?	N/A
N/A	Landing Length (in)	N/A	N/A	DWS Provided?	N/A
N/A	Landing Width (in)	N/A	N/A	DWS Contrast?	N/A
N/A	Landing Slope (%)	N/A	N/A	DWS Length (in)	N/A
N/A	Landing X Slope (%)	N/A	N/A	DWS Full Width?	N/A
N/A	Landing Curb? (Y/N)	N/A	N/A	DWS Offset (in)	N/A
N/A	Shared Landing?	N/A			
N/A	Gutter Ponding?	N/A	N/A	Gutter Slope (%)	N/A
N/A	Gutter Lip Ht (in)	N/A	N/A	Gutter X Slope (%)	N/A
N/A	Painted X Walk1?	No	N/A	Painted X Walk2?	No
	X Walk 1 Direction	To NW		X Walk 2 Direction	To W
N/A	X Walk 1 Width (in)	N/A	N/A	X Walk 2 Width (in)	N/A
	X Walk 1 Slope (%)	3.5		X Walk 2 Slope (%)	3.7
	X Walk 1 X Slope (%)	3.5		X Walk 2 X Slope (%)	1.1

N/A	Ramp inside XWalk1?	N/A	N/A	Ramp inside XWalk2?	N/A
	Road Slope (%)	3.1	N/A	Clear Space?	N/A
	Road X Slope (%)	2.3	N/A	Clear Space to XWalk (in)	N/A
N/A	Any Obstructions?	N/A	N/A	Storm Grate/Utility Hazard?	N/A
	Obstruction Type			Storm Grate/Utility Type	
		N/A			N/A
			Yes	Surface Condition? (G/P)	Good

Remove & Replace Curb Ramp With Two New Directional Ramps or Equivalent.
