Access Compliance Report

Public Rights-of-Way

(Curb Ramps)

Intersection ID: 15514	Main Street: COLDSTREAM_LN	Cross Street: N WENDOVER RD	Location: NW
ADA ID: 83EE8042A6A6	Ramp Type: Perp	Initial Pass/Fail: Fail	Overall Compliance: No
Severity Score: 46.25			
Codes/Mitigation Info/Possible Solution		Field Measurements/Component Compliance

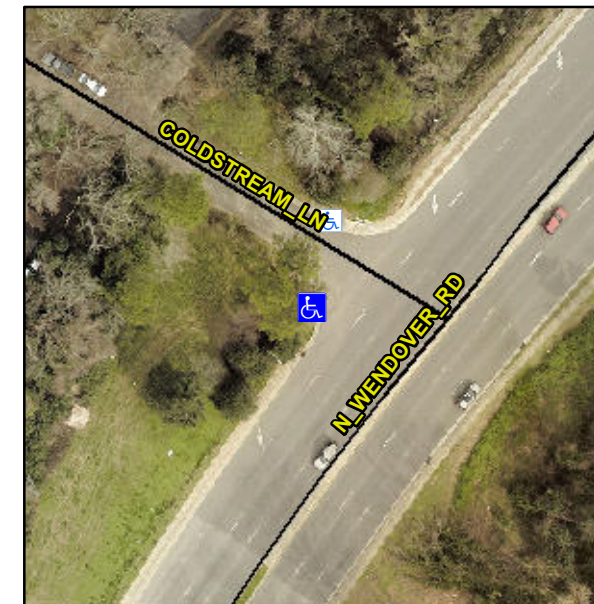
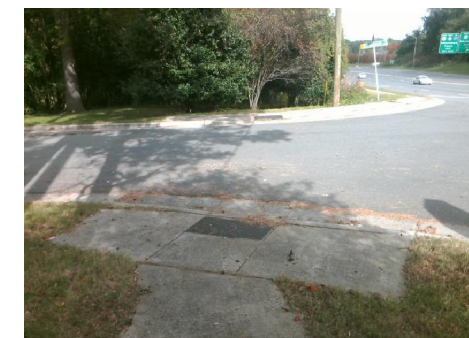
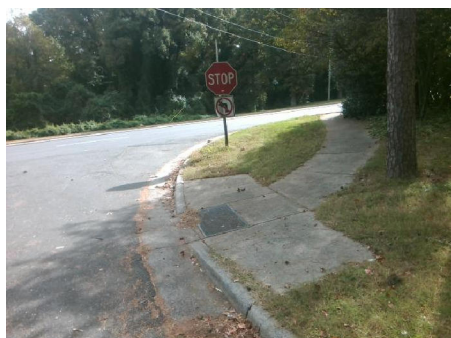
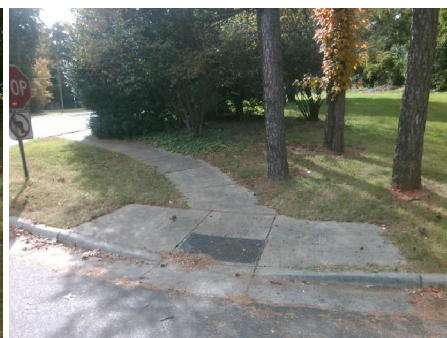
Not Found, R304.5.1, R304.2.2, R304.5.3

Compliance	Description	Data	Compliance	Description	Data
N/A	Ramp Length (in)	65.0	No	Ramp Slope (%)	11.3
No	Ramp Width (in)	45.0	No	Ramp XSlope (%)	7.4
N/A	Flare Type LT	N/A	N/A	Flare Type RT	N/A
N/A	Flare Slope LT (%)	N/A	N/A	Flare Slope RT (%)	N/A
N/A	Flare Traversable LT?	N/A	N/A	Flare Traversable RT?	N/A
N/A	Landing Length (in)	N/A	N/A	DWS Provided?	N/A
N/A	Landing Width (in)	N/A	N/A	DWS Contrast?	N/A
N/A	Landing Slope (%)	N/A	N/A	DWS Length (in)	N/A
N/A	Landing X Slope (%)	N/A	N/A	DWS Full Width?	N/A
N/A	Landing Curb? (Y/N)	N/A	N/A	DWS Offset (in)	N/A
N/A	Shared Landing?	N/A			
N/A	Gutter Ponding?	N/A	N/A	Gutter Slope (%)	N/A
N/A	Gutter Lip Ht (in)	N/A	N/A	Gutter X Slope (%)	N/A
N/A	Painted X Walk1?	No	N/A	Painted X Walk2?	N/A
	X Walk 1 Direction	To NE		X Walk 2 Direction	N/A
N/A	X Walk 1 Width (in)	N/A	N/A	X Walk 2 Width (in)	N/A
	X Walk 1 Slope (%)	0.3		X Walk 2 Slope (%)	N/A
	X Walk 1 X Slope (%)	3.7		X Walk 2 X Slope (%)	N/A

N/A	Ramp inside XWalk1?	N/A	N/A	Ramp inside XWalk2?	N/A
	Road Slope (%)	N/A	N/A	Clear Space?	N/A
	Road X Slope (%)	N/A	N/A	Clear Space to XWalk (in)	N/A
N/A	Any Obstructions?	N/A	N/A	Storm Grate/Utility Hazard?	N/A
	Obstruction Type			Storm Grate/Utility Type	
		N/A			N/A
			Yes	Surface Condition? (G/P)	Good

Possible Solutions:

Remove & Replace Entire Ramp.
